Date Issued: 1 June 2016

Incident Title: Pole Collapse

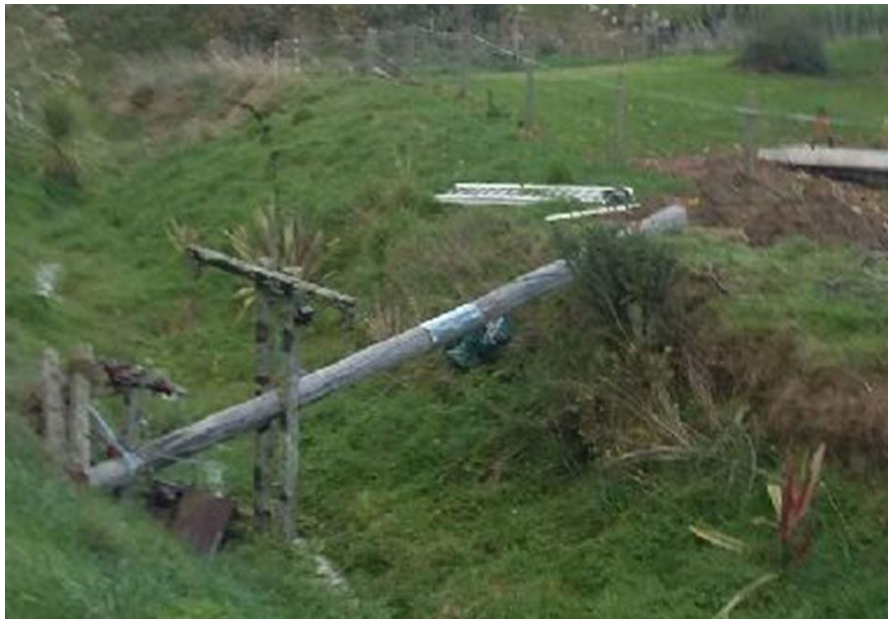
On May 19 2016, a Balclutha based line crew were at a site at Beaumont to replace a pole. An assessment was made of the pole condition prior to a line mechanic placing a ladder against the pole, to give access to a low voltage line attached to the pole. After the low voltage wires were cut away, the pole collapsed while the line mechanic was still on the ladder and attached to the pole.

The line mechanic suffered no major injuries but was given first aid treatment by the other members of the crew but for bruising and discomfort from whiplash.

- All poles must be assessed prior to climbing – a pole that is not red-tagged may still be unsafe to climb.
- Where there is any doubt about the integrity of a pole then it must be accessed by using an EWP and/or securely held with a crane prior to any work being done on it – especially before any change of loading on the pole.
- Poles assessed as unsafe to climb must be immediately red-tagged and System Control notified of the details
