FIRST ALERT

Date: 15 May 2016

Issuer applied earth placed in incorrect position

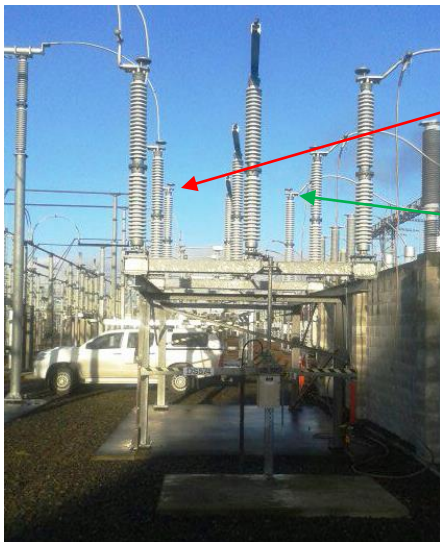
Disconnector 574

During switching an issuer applied earth was placed on the live 220kV Bus side of Disconnector 574, at Albany Substation. As a result the bus bar protection operated, tripping the relevant bus. No persons were injured and at the time of the event there was no reported equipment damage or loss of supply.

Where earth was connected (incorrect position)

Where earth should have been connected (correct position)

- Switching was stopped and the area was made safe
- Event reported to Electrix and Transpower management
- Replacement operator was inducted and operating duties handed over to complete the switching
- Maintenance switchers are reminded that when the operating sequence is interrupted, or you are distracted from your task, you must return, check the sequence and recommence activities from the previous step
- Always apply earths immediately after testing to prove de-energised
- An ICAM investigation is underway to establish the facts
