TRANSPOWER

Date: 05/11/2016

# FIRST ALERT

## HAYWARDS SUBSTATION – Damage to Disconnecter 73 contacts

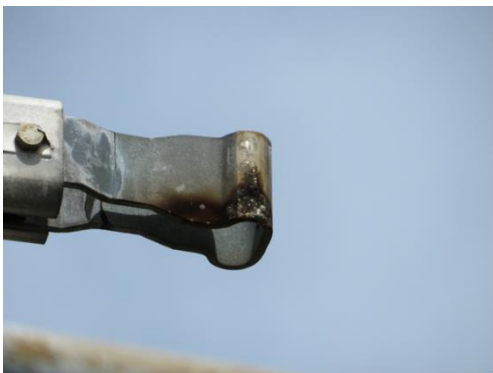
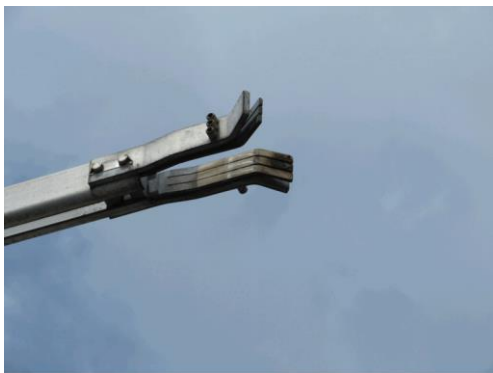
During the sequence a team member marked off an item on the sequence as completed without the item being physically completed on the network.

This led to a situation where Haywards T1 was isolated from the Bus “under load” resulting in a flashover on the contacts of disconnector 73 resulting in damage to the disconnector contacts.

- Maintenance Switchers immediately notified NGOC of the incident who then offloaded the Transformer to allow the sequence to be completed safely.
- Work on the affected equipment was stopped and a de-brief was held by the Broadspectrum Delivery Manager.
- An investigation has commenced and a Safety Alert with learnings will be made available following the outcome of that report.
