# FIRST ALERT

Date 13/02/2015

## Pulley block failure during 220 kV cable installation

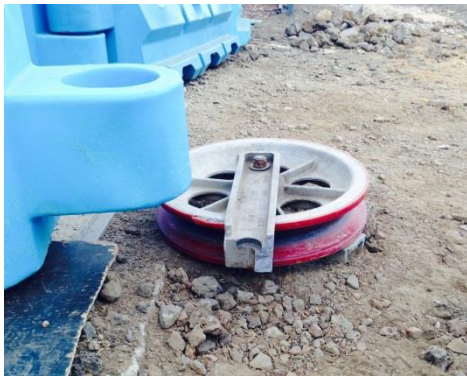
A worker sustained serious injuries to his legs when a pulley block, which was being used as part of the rigging set up for winching a 220 kV cable into position, suffered a catastrophic failure. The failed pulley block flew some distance and struck the worker in the lower legs. The worker has fractures to both legs and has undergone surgery. A long recovery time is expected.

The failed pulley block

- Work was stopped and the injured person attended to. Emergency services and Worksafe NZ were contacted and attended the scene.
- Investigations have been initiated by all parties involved.
- Until the root cause has been identified and as a precaution, Powerhouse brand 380mm pulley blocks are not be used on Transpower sites.
- For all other pulley block use, ensure that rigging loads are engineered and components are selected within the safe working load (SWL) and appropriate for the application and that workers are kept clear of the line of fire during winching operations.
