safety alert

Tree Contact

E15935

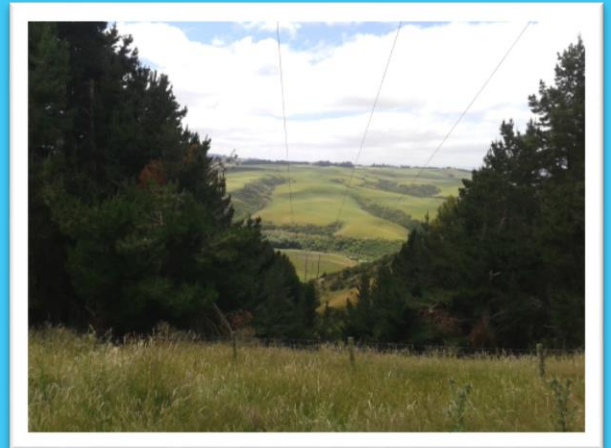
A tree contacted the Transmission line

While undertaking the removal of approximately 150 pine trees in a line corridor a trees being felled has inadvertently contacted one phase of a Transmission line.

- Changed from supervising a contractor to undertaking the felling of trees not discussed or managed
- Negotiation for tree removal started 2008 with agreement to fell not until 2014
- Steepness and landowner site restrictions meant plant could not be used or fences removed
- Trees within x2 MAD line clearance felled without all the controls in place
- Fall distance trees are not covered by the Tree Regulations

Number of contributing factors were identified which allowed for the inadvertent contact of the line.

- Right equipment not used
- Work site not set up properly
- Procedure/instruction not followed
- Inadequate Communication
- Inadequate supervision
- Poor environmental conditions

- Operation suspended
- Investigation completed
- Vegetation workshop addressing concerns undertaken

Processes must be followed and when changes occur a stop think and/or hold point should be undertaken to ensure activities remain within the scope of approved procedures and work processes, and are safe and meet both Electrix and Transpower needs.
