Safety Advice 59-2015 (June)(NZ)

Unison Safety Alert dated 25 June 2015 concerns a significant crack being identified along the steel boom weld seam in an elevated work platform (EWP).

Subject	Crack in EWP Boom		
Alert Number	SA 098	Date Issued	25/06/2015
Issued by	UCSL Health and Safety Manager	Effective	Immediately
Authorised by:	Chief Executive Contracting

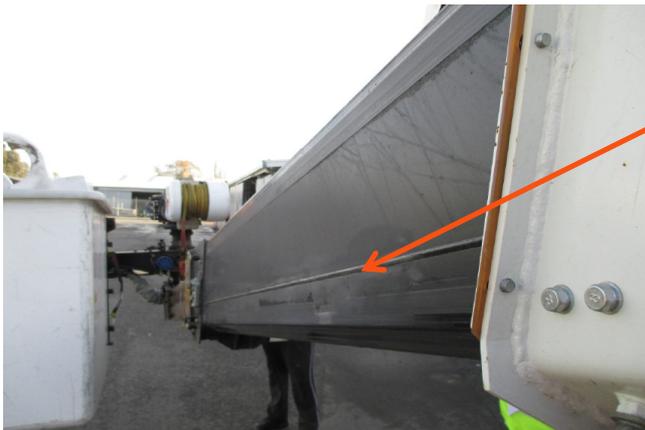
During maintenance on an elevated work platform (EWP) truck; a significant crack was identified along one of the steel boom weld seams.

The boom is a 2007 Aichi telescopic model SN15A.

Photo 1: Steel boom section with failed weld

The actual cause of this weld failure is still to be determined at this time.

Two months earlier the boom had undertaken its 2-yearly acoustic test. The investigation will primarily focus on two key factors. Firstly, the standard of the weld fusion, and secondly, the integrity of the acoustic test.

In light of this incident it is important that the boom weld seam is checked on similar EWPs and any defects found reported back to EEA.

As an immediate precaution all EWP's will be inspected by a certified engineer.
