# *Safety Advice 21-2014 (Mar) (NZ)* *(Transmission)*

# FIRST ALERT

Date 20 March 2014

## Flashover on Islington 66kV C15 Capacitor Bank

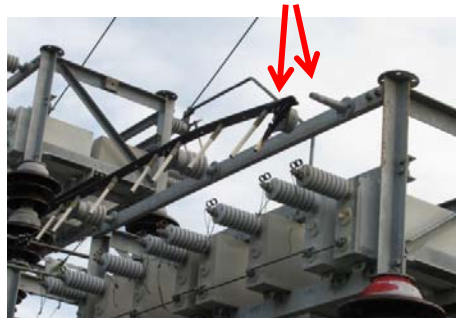
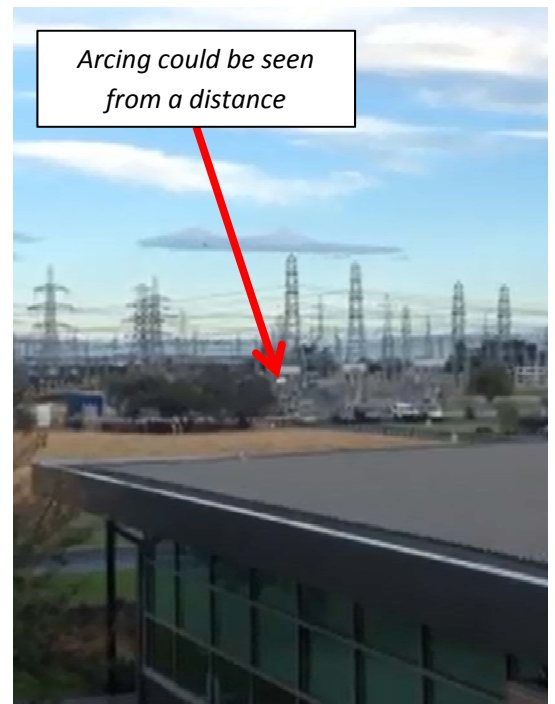
- 8 capacitor cans have blown fuses and one can is leaking oil.
- Insulator support to one of the capacitor cans was damaged.
- One HV terminal of the Unbalance CT is loose.
- Un-availability of reactive plant to SO.

Damaged support insulator

- Investigations continuing on the root cause.
- Full testing on C14 to C16 banks.
- The C15 CT will be repaired or replaced.
- Engineering review of other similar capacitor banks.
