## **ISSUE DEFINITION**

Eaton received report of an unsafe situation occurring with the operation of a Xiria ring main unit. Mainpower safety announcement reference number 3066 dated 9 October 2009 refers.

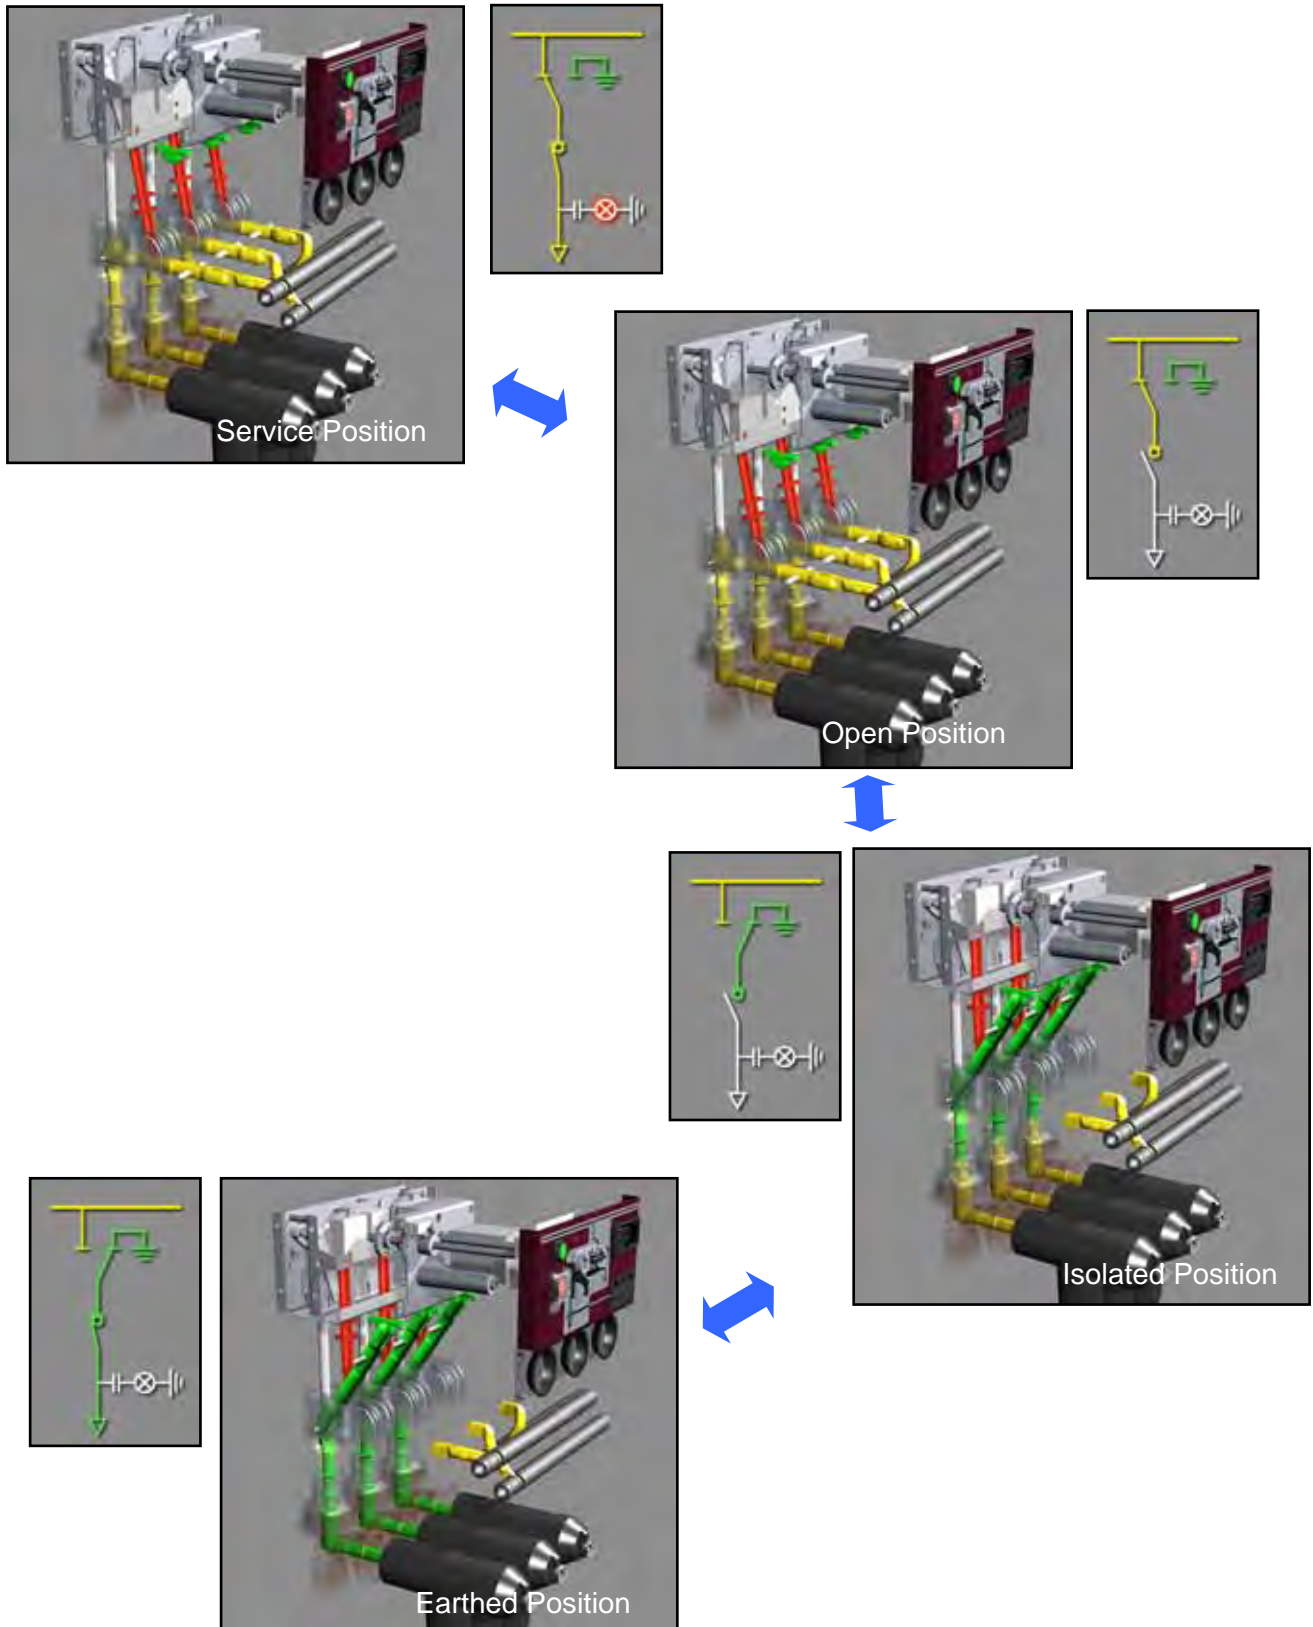
The possible switching positions of the changeover switch and the vacuum interrupters are shown in the illustrations below:

Our opinion is that it may be more beneficial to incorporate into operating procedures the use of one of the key features on a Xiria ring main unit, that of the viewing windows for verification of switching status.

This provides positive indication of the switch positions and optimal reassurance.

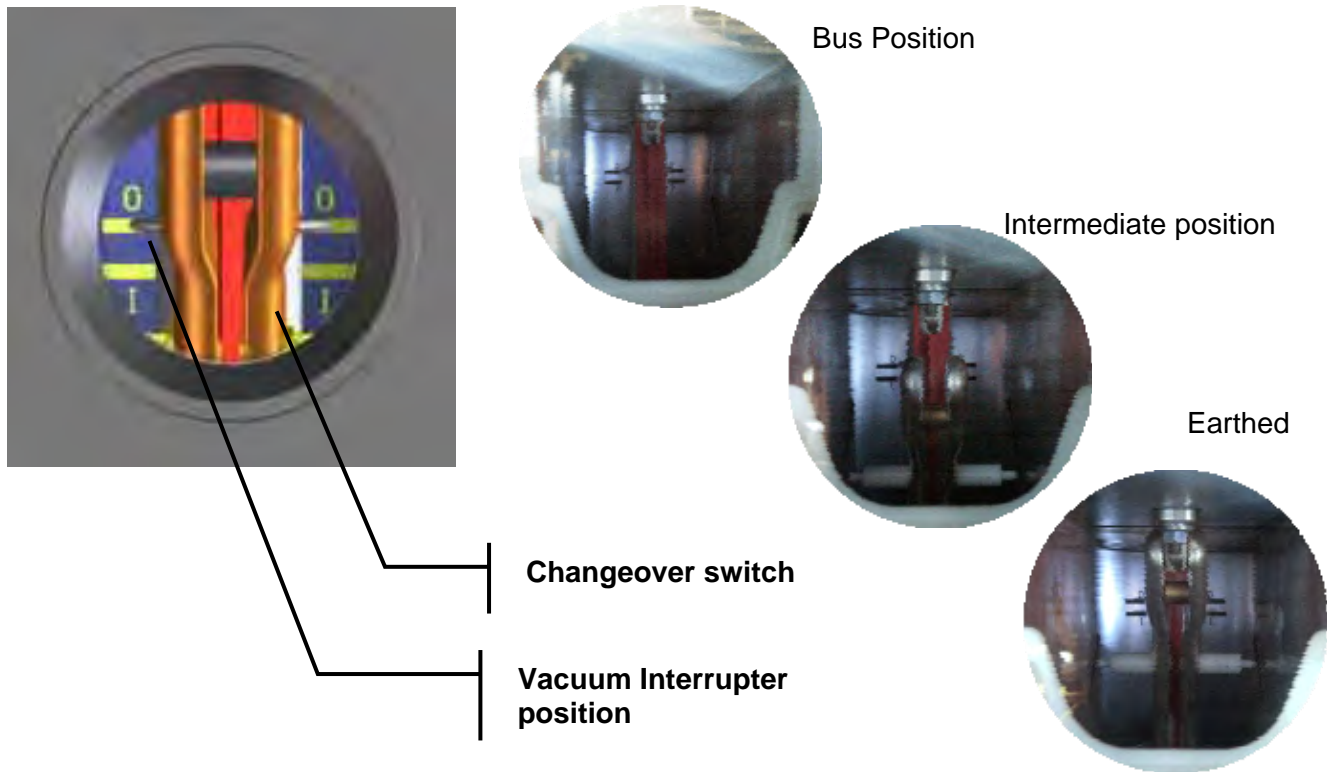
The position of the vacuum interrupters and the changeover switch can be confirmed visually through the viewing ports as in this pictorial representation.

Eaton concurs with the merit of inspection for missing fixing hardware, however only in the event that rectification work is performed on the unit in question. Our recommendation is to incorporate visual checks of the switching status as part of the normal operating procedure. This utilises the key benefit of visible isolation/earthing through the viewing ports, specifically developed to meet the demands of the industry for personnel safety in operation.
