## *Safety Advice 36-2013 (Oct) (Nov)*

## Modified extension lead electric shock

Electrix Event Number 12585

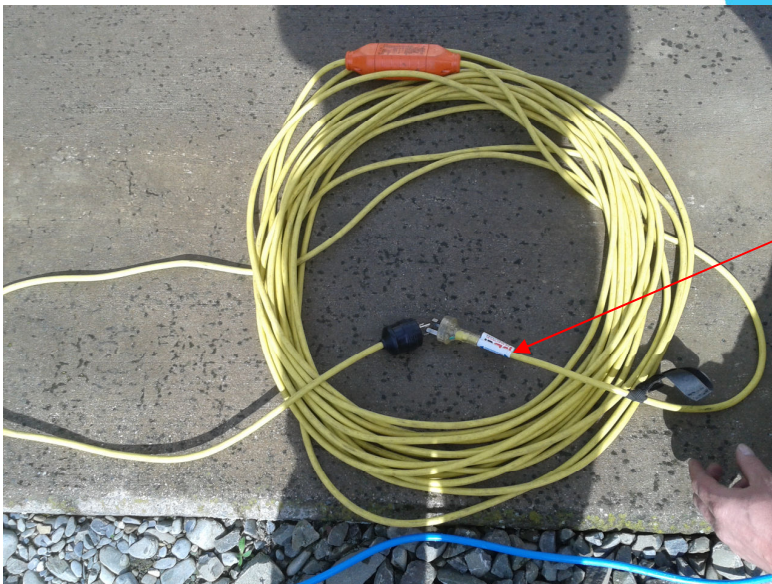
Photograph 18.10.2013  
Modified extension lead

As the employee handled the lead his thumb came into contact with a live part. On close inspection he identified that the female socket had been removed and replaced by a male plug.

Note:  
The lead has been modified and is fitted with 2 male plugs

The initial investigation has established that;  
The lead had an 'In test' tag installed  
The lead had an RCD protection device 'hard wired'

Until the root cause(s) have been identified staff must ensure that prior to utilising plant and equipment a thorough visual inspection is completed, where practical all fixings, fittings, stress and connection points are checked. Modifications, including repairs need to be electrically safe, tested and certified as appropriate.
