## *Safety Advice 40-2013 (Oct) (NZ)*

# FIRST ALERT

## Cut to Elbow by Chainsaw

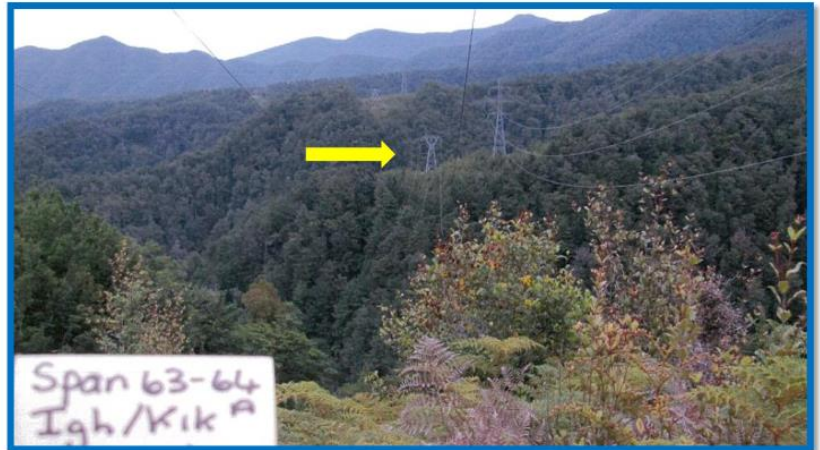
A Vegetation Controller was working horizontally along an area of bank when a section of ground gave way beneath his foot. As he slipped downward and forward his right hand caught the trigger mechanism of his chainsaw and the blade flicked over causing a cut to his left arm, just above the elbow. The cut required two stitches.

- Hospital attention. Two stitches to arm. Able to return to full duties following morning.
- Meeting held with field staff to discuss incident. Footwear sighted as contributing factor. Options to be investigated which incorporate forestry components and meet with service specification requirements. Discussed fatigue management assessment and risk slider undertaken prior to work. Hydration and fatigue not considered to be contributing factors.
- Chainsaw inspected. In full working order. Past inspections reviewed. No previous issues noted.
- D&A Testing of work crew. No issues.
