Safety Advice 53-2013 (Dec) (NZ) *(Transmission)*

Concrete Block Lifting Point Fails

Temporary by-pass installation for Mobile Sub at Murchison Substation

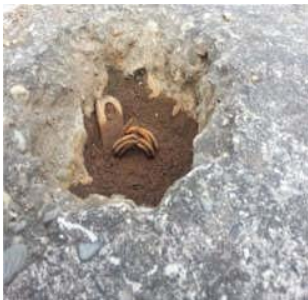
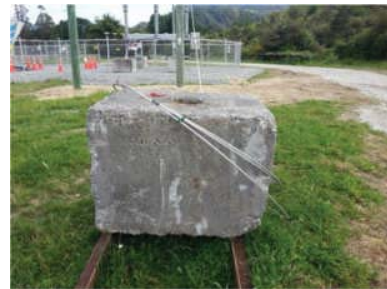
Description: During the construction of the temporary by-pass 110kV line at the Murchison substation a 2 tonne concrete block was being positioned onto its cradle when the lifting eye failed. The block fell approximately 400mm to the ground, no injuries were sustained.

- The lifting eye is generally recessed to allow for stacking, the recessed hole fills with water and corrosion begins.

- Work ceased while block was inspected
- The block was moved using the thumb of an excavator and subsequently was utilised to move all the concrete blocks on site.
- All blocks to be inspected, either new blocks will be fabricated or new lifting eyes will be inserted in existing concrete blocks.
