# *Safety Advice 01-2005 (NZ)*

## **FATAL INJURIES DURING 66kV LINE WORK**

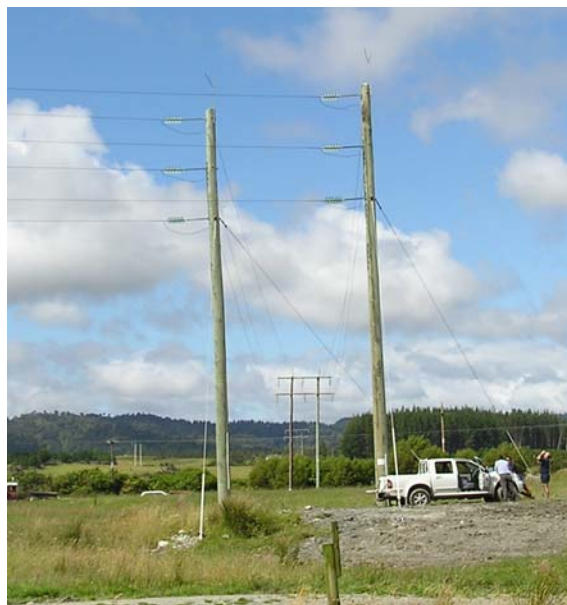
During the process of raising the out of service conductor to its final position using a chain hoist and whilst standing on a pole step of the strain pole, a lineman received fatal injuries when this conductor came in contact with the other in service conductor two spans away from the work site.

A preliminary review of the earthing process used indicates that although the conductors were earthed to a driven earth stick, this earthing arrangement did not achieve an equipotential zone as recommended by SM-EI Rule 3.603 (f). At this point it is unknown as to what effect this would have had on the event that occurred - this is being further investigated.
