# Safety Advice 04-2005 (NZ)

## RING MAIN UNIT FAILURE

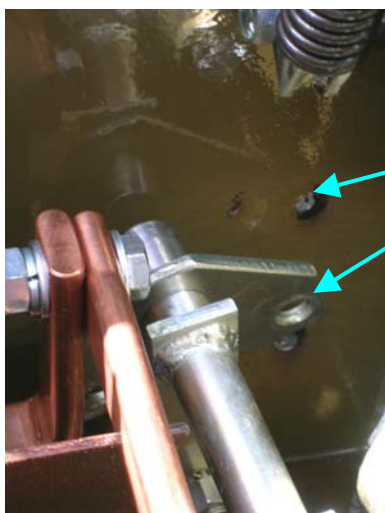
The operating mechanism shaft is held in place by, and rotates within, a steel retaining plate. This plate is secured by two M10 studs welded to the insulating oil tank. It was found that the spot/stud welding of the studs to the tank lacked in penetration and failed due to loading tensions. The spring tension on the operating shaft pushed the shaft in close proximity of the main busbar.

Location from where studs have broken away

Broken studs

It is recommended that the switches be inspected and repaired if necessary by removal of surface mounted studs and replaced with studs welded through the tank wall as previously highlighted.
