## SAFETY BULLETIN SB1/2019

### Live 11kV Cable Cut in Error

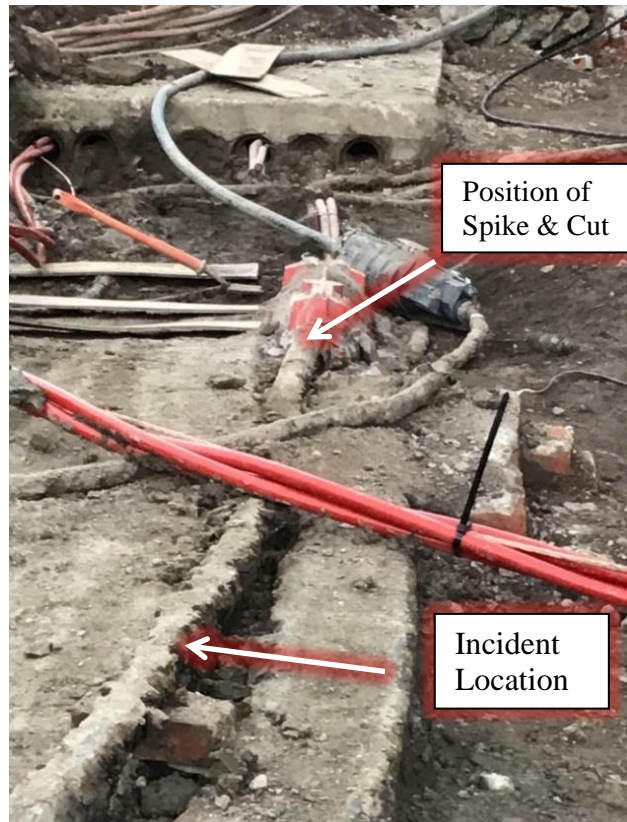
A joint pit had been excavated and several 11kV cables had been exposed. Multiple cables were in close proximity to each other. The correct cable to be worked on had been positively identified by the SAP, spiked and cut. A Permit to Work was issued to a jointer to work on the identified and spiked cable.

The jointer chose a convenient position along the length of exposed cable to carry out the jointing work and proceeded to cut the cable at that position with a reciprocating saw.

Between the incident location and the spiking position one of the cables was not uncovered for about 300mm. This cable could not therefore be physically traced along its entire length between the spike position and the proposed cut.

As not all the cables in the vicinity of the proposed work been fully exposed, this led to an assumption that the cable being cut was the correct one.

- ST:OS4A states that a cable must be physically traced from the point of work to an already identified point.
- Where any section of cable, however small, cannot be physically traced, a new identification in line with Distribution Safety Rule (DSR) 4.1 and ST:OS4A shall be completed.
- Where reasonably practicable, other exposed cables within the vicinity of the work location should be screened as not positively identified and potentially live.
