TITLE – FALL ROPE DESIGN FLAW - UPDATE

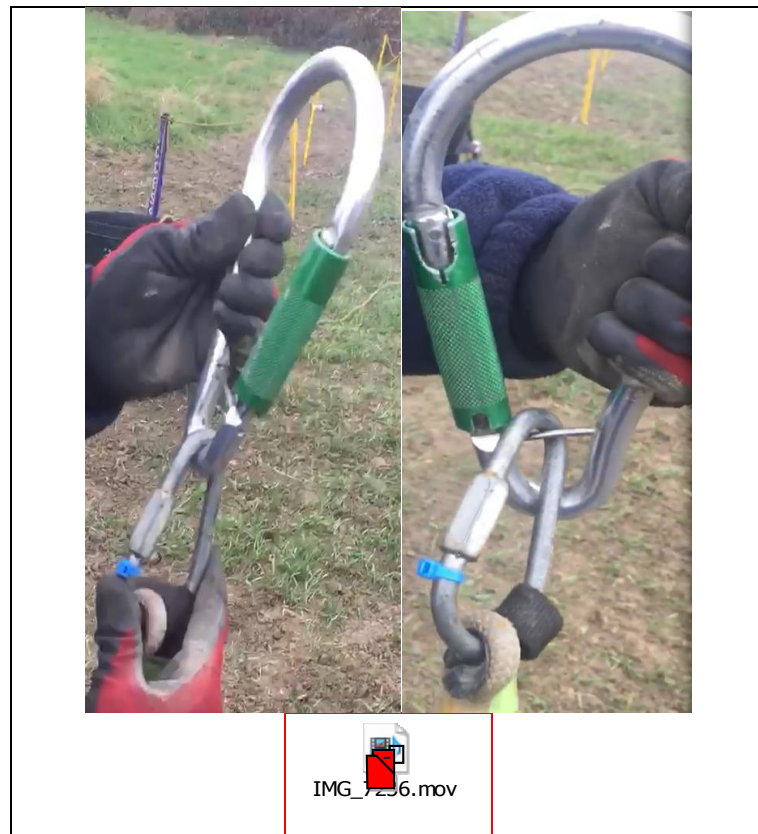
- Whilst working on a plant status scheme on the 4ZH route – Tower 94
- A linesperson reported that when accessing a ladder via their fall rope they noticed that the pear karabiner had inadvertently threaded through the gate of the scaff hook.
- This could have caused a catastrophic fall from height if the individual had not noticed as all of their weight would have been held on the scaff hook retaining pin.
- The linesperson effected by this situation re rigged the fall rope the correct way and proceeded on with their daily tasks
- A near miss was raised as soon as it was safe to do so – **IMS 565679**
- No one was injured in this incident.

- Raise awareness via safety note
- Notify Equipment and procedures engineer so that this flaw can be designed out of future fall ropes
- Watch embedded video which highlights how easy this can happen.
- Issued fall ropes of this design need to be removed from service and disposed of as per working at height PPE guidelines.
- None issued Stock items held at base locations shall be quarantined until further notice.
- Report stock amounts back to Equipment and procedures Engineer.
