OPERATIONAL BULLETIN

Document No:	HSS 406 OB 163	Issue Date:	17 January 2019
Type:	Operational Bulletin		
Subject:	Checking of neutral links when connecting a generator		
Applicable Areas:	All	Applicable Job Roles:	Anyone carrying out work in a Substation
Issued By:	HSS Team		
Circulation:		 Network Operations ⋈ EPN ⋈ LPN ⋈ SPN ⋈ Connections Services ⋈ Distribution Capital Delivery ⋈ Highway Services □ Logistics ⋈ Network Control ⋈ Powercare □ Transport Services □ SHE&TTA ⋈ In Business safety team ⋈ Safety Reps □ Strategy and Regulation ⋈ UK Power Networks Services

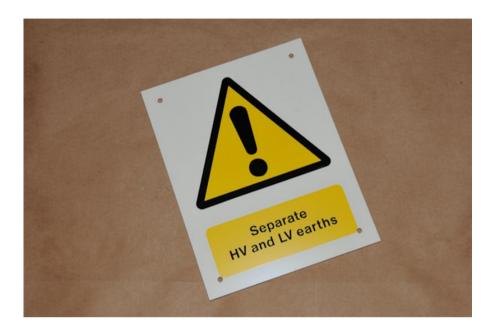
Where HV and LV earths are separated, the following warning sign should be visible on site.
