Issue No:	NA 77 v2.0	Issue Date:	07 February 2019
Type:	Vehicle Safety		
Subject:	Toyota Hilux MEWP Vehicles wheels cracking		
Applicable Areas:	All areas	Applicable Job Roles:	Toyota Hilux Platform Vehicle Drivers
Issued By:	Transport	Author:	
Circulation: <ul style="list-style-type: none"> <input type="checkbox"/> All UK Power Networks Staff <input type="checkbox"/> Asset Management <input checked="" type="checkbox"/> Capital Programme & Procurement <input type="checkbox"/> Connections <input checked="" type="checkbox"/> Contractors <input type="checkbox"/> Customer Services <input type="checkbox"/> Finance <input checked="" type="checkbox"/> G81 External website <input type="checkbox"/> HR & Communications <input checked="" type="checkbox"/> ICPs (Independent Connection Providers) <input checked="" type="checkbox"/> IDNOs (Independent Distribution Network Operators) <input type="checkbox"/> Information Systems <input type="checkbox"/> Legal <input type="checkbox"/> Meter Operators 		<ul style="list-style-type: none"> <input type="checkbox"/> Network Operations <ul style="list-style-type: none"> <input checked="" type="checkbox"/> EPN <input type="checkbox"/> LPN <input checked="

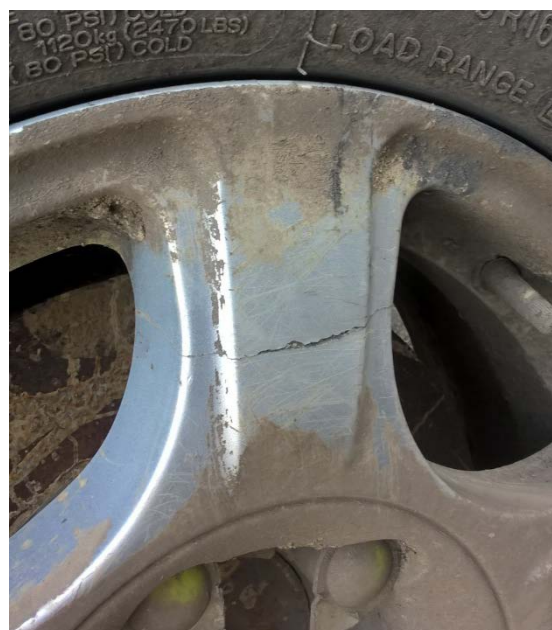
Fig 1

- This action is taken following the outcome of detailed examination of all wheels over the last two weeks
- Any vehicle removed from service during the last two weeks will be given priority, all other vehicles can continue to be used as normal - provided that its ongoing daily checks are rigorously carried out including the checks for cracks
- Staff are reminded of the importance to check tyre pressures regularly and maintain them at the correct pressures. All vehicles should display tyre pressure on stickers, above the wheel arch. See Fig. 1
- This action allows for detailed plans to be drawn up leading to the vehicles replacement.

FRONT		REAR	
TYRE PRESSURE	44 PSI (3.1 BAR)	TYRE PRESSURE	65 PSI (4.5 BAR)
WHEEL TORQUE	89 LBS/FT (120Nm)	WHEEL TORQUE	89 LBS/FT (120Nm)
WARNING		WARNING	
NO LUBRICANT TO BE USED ON STUD OR HUBS		NO LUBRICANT TO BE USED ON STUD OR HUBS

Transport are engaging Universal Tyres to undertake a full wheel and stud change over the next five weeks. Managers will be contacted to arrange a suitable date for the work to be completed as soon as the parts become available.
