# PANEL OF INQUIRY

## ScottishPowerExpress

Reference no.: EXP-14-093

## LIVE 11,000 Volt Pole Falls Onto Excavator

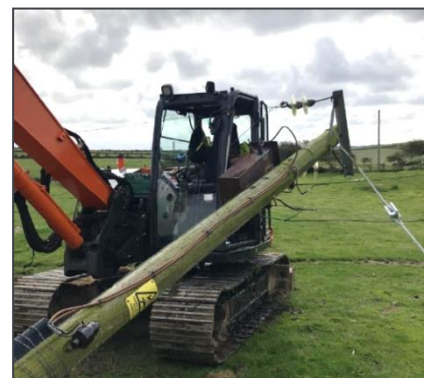
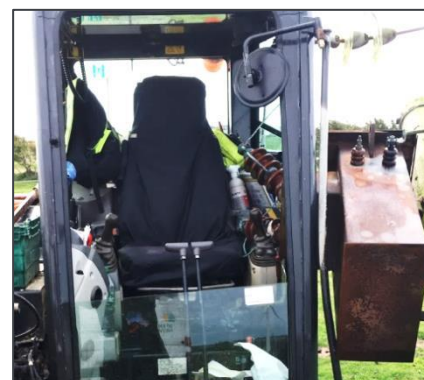
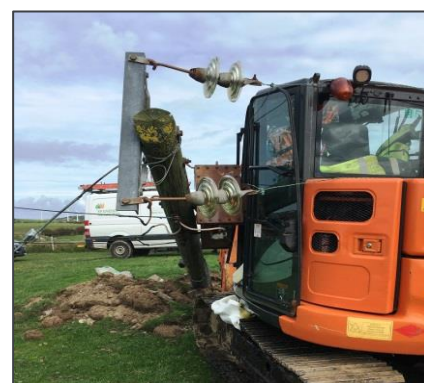
On Saturday 15th September 2018, an energised 11,000 volt wood pole substation became unstable as a direct result of inadequate planning of the task, which led to unsafe digging practices.

Consequently the pole fell onto the excavator, with the transformer entering and coming to rest in the operator's cab.

During this time, the operator was trapped inside the excavator only inches away from the transformer's high voltage terminals.

The Panel concluded that the root cause for the incident is the ineffectiveness of how the main contractor set their sub-contractor to work, through failing to:

- Ensure the working party were sufficiently competent to undertake the task;
- Effectively plan and apply a safe system of work for their sub-contractor;
- Adequately recognise and identify risks and hazards;
- Effectively apply the control of risks; and
- Provide adequate on-going management, control and monitoring of the work activity.

The Panel noted that whilst the operator and working party held the required training and experience to operate the plant and undertake excavations, they were not considered sufficiently competent to excavate in proximity to electrical poles nor to recognise or address the hazards present.

***Competence should take into account the ability to not only undertake the task but also the ability to recognise the wider environment and manage potential hazards.***
