## Faulty 11kV OH Line Tension Insulator

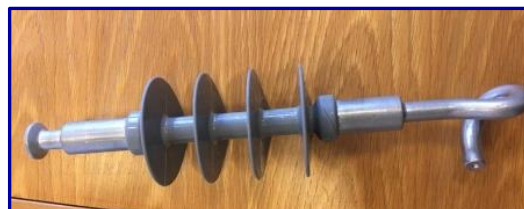
During OH Line installation works on Thursday 16<sup>th</sup> May 2019 at Glencorse, Ae Village in Dumfries District, an 11kV tension pigtail insulator, supplied from Mosdorfer, failed on release of pull lift tension.

**Figure 1.** Faulty pigtail OHL Insulator

- Prior to installation, all polymeric type tension insulators (all voltages) shall be visually checked to ensure that they have been crimped at both ends. See Figures 4 & 5.
- Visually inspect all insulators in local / van stock before use and quarantine any with Mosdorfer "11 2018" date code, as shown above. See Figure 6.
- Collate any quarantined insulators and contact Jamie McDonald to arrange inspection: ([Jamie.Mcdonald@spenergynetworks.co.uk](mailto:Jamie.Mcdonald@spenergynetworks.co.uk))

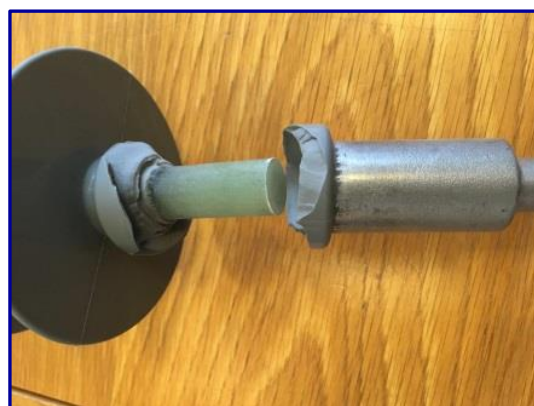
On inspection, it was found that the steel pigtail fitting of the insulator was not crimped. The insulation had held the insulator together in transit and storage, but failed when put under tension during installation. (See Figures 2 and 3).

**Figure 2.** Separation of pigtail end fitting

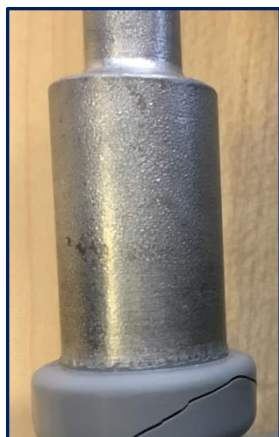
**Figure 3.**  
No Compression on  
Mosdorfer Insulator

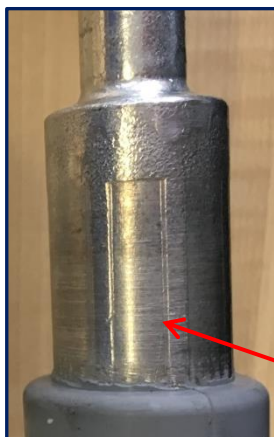
**Figure 4.**  
Correctly Compressed  
Mosdorfer Insulator

Note: Quality compressions are only lightly indented. The Henley insulator picture is shown for comparison purposes.

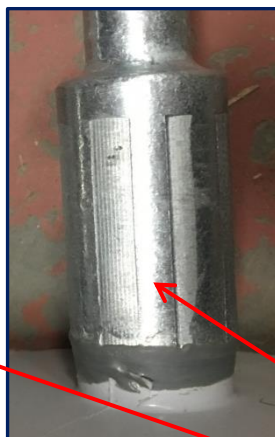
**Figure 5.**  
Correctly Compressed  
Henley Insulator

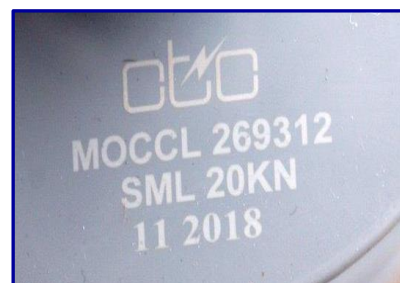
**Figure 6.**  
Manufacturer and  
batch code details
