Newsflash – 2019 06**16 May 2019 - Internal**

Cable trough cover

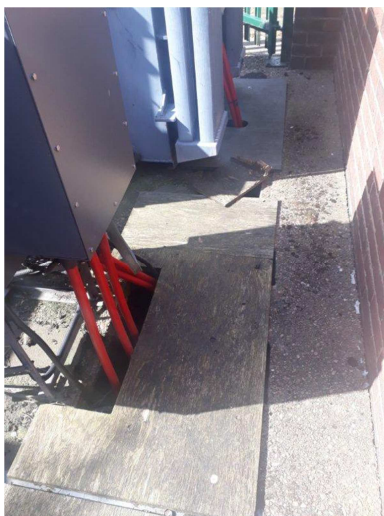
Internal and External cable trough and trough covers are present on H.V. and E.H.V. Operational sites across both our license areas. The covers are predominantly of a reinforced concrete, metal, marine grade ply and GRP construction. Structural deterioration of the trough covers is often on the underside and as such a visible inspection is not an adequate assessment for the condition of the covers.

We are currently in the process of identifying and rectifying this asset but we are particularly interested in identifying Outdoor Equipment sites fitted with plywood trough covers. (See example below.)

Plywood cable trough covers

Operational staff are therefore reminded that, in line with our previous guidelines, trough covers should not be subject to foot or vehicle traffic . Before entering a site, Operational staff should risk assess routes within the site to ensure access and egress is via routes that do not involve stepping on trough covers.

If plywood covers, located in these sites are encountered, they should be reported through our 159 reporting procedure. Missing or misaligned covers that present a trip or falling hazard should also be reported in the same manner.
