## SPIKING OF HV CABLES – Update

| <b>Issue date</b> | 6 <sup>th</sup> June 2019 |
| <b>Issued by</b> | Steve Lockett, System Operations Manager |

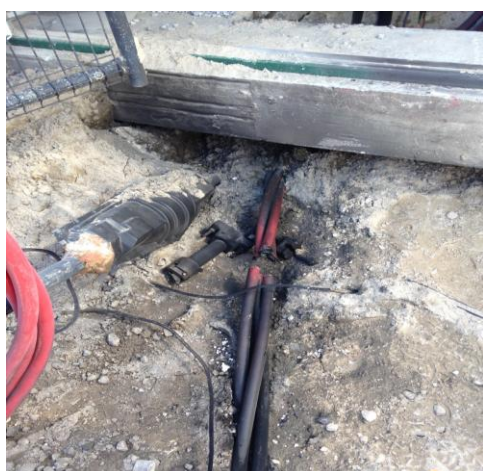
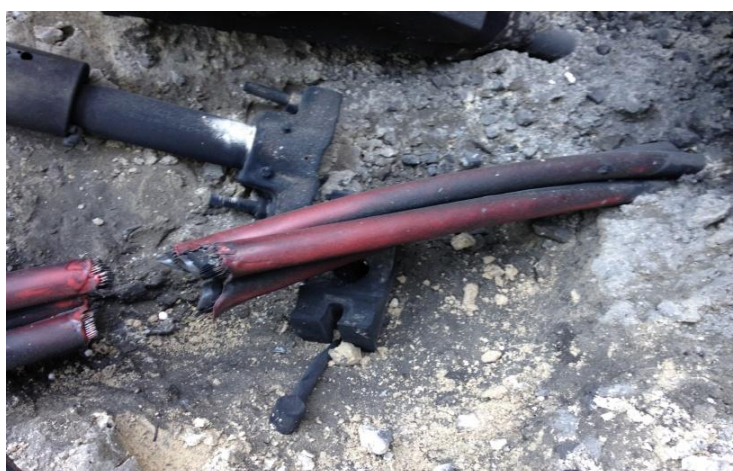
During work to loop in a new HV substation, a live 6.6kV cable was spiked in error causing an explosion and the subsequent injury to a jointer requiring treatment in hospital.

Owing to the substation's concrete ring beam, the HV cable was not sufficiently exposed to enable its identification by visual trace. Through moving of the cable manually from inside the joint hole, a noticeable movement was observed on a cable entering the earthed cable box. The SAP believed the correct cable had been identified. However, this proved not to be the case. The manual manipulation of an unexposed cable as means of identification is unreliable and is not an approved method of identification. Believing he had identified the correct cable, the SAP marked the exposed cable in the joint hole and requested the spiking gun be attached by a jointer.

Upon spiking the live cable there was a large explosion which immediately filled both the joint hole and substation with flames, arc products and smoke. The second jointer, positioned just inside the substation threshold, was engulfed by the explosion, receiving flash burns to his lower arm and head. The SAP escaped injury by shielding behind the switchgear.

| Safety Procedure | Reference |
|---|---|
| A SAP shall ensure all HV cables to be worked on are correctly identified and proven dead. | DSR 5.9.2 and CP606 B02 - 1.2/3.0 |
| If the visual tracing method of identification is used, the cable shall be traced along its entire length from a point where it is connected to earth to the point of work. | CP606 B02 - 2.3.1 |
| Where the visual tracing method is restricted, the cable can be identified by placing a ring of suitable material around the cable from a point where it is connected to earth and passing it along the cable to the point of work. | CP606 B02 - 2.4.1 |
| Before the cable is spiked, a SAP shall ensure that the lanyard is extended to at least 7 metres and all personnel and members of the public are at a safe distance. | CP606 B12 - 2.1.3 |

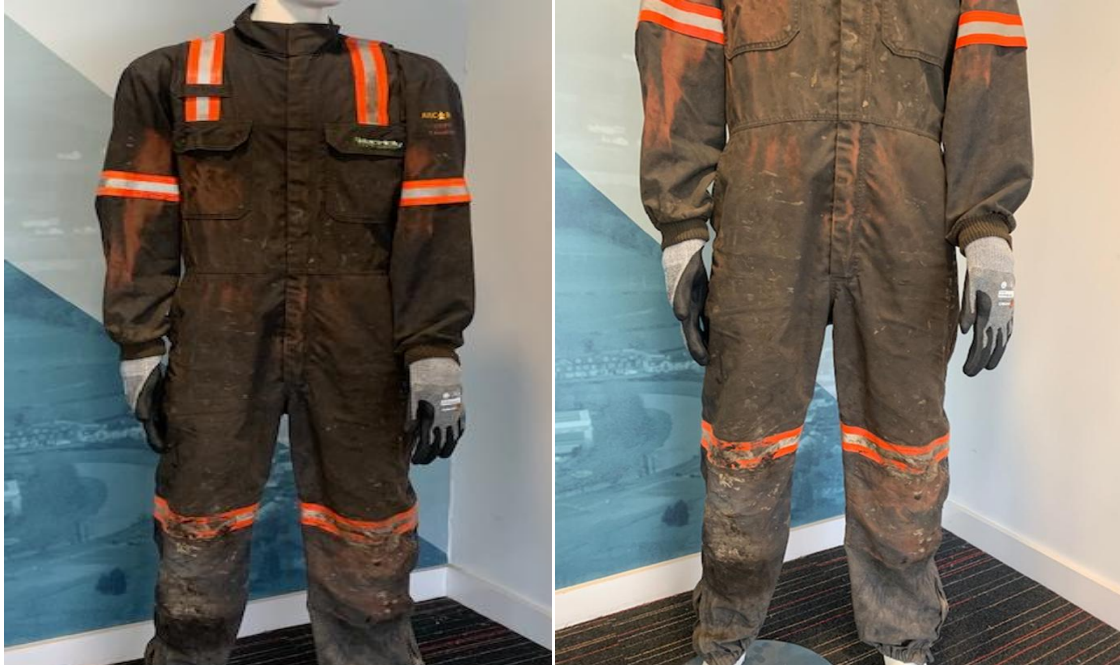
We have decided to share these pictures of the injured jointer's coveralls. The dusky orange patches around the legs, stomach, torso and arms are the scorch marks left from the flash. Had this incident occurred prior to introduction of the arc-resistance coverall, the injuries would have been life changing or worse. This is a stark reminder that when primary risk controls fail, PPE is the last form of defence and why it is mandatory to wear it. During use, the arc resistant coverall shall be worn correctly, with both sleeves covering the arms down to the wrist and fully fastened at the front to the neck.

| Safety Procedure | Reference |
|---|---|
| PPE identified for the task shall be worn at all times. | As per Standards for PPE and relevant CP's |
