Polymeric Pin Insulator Failure

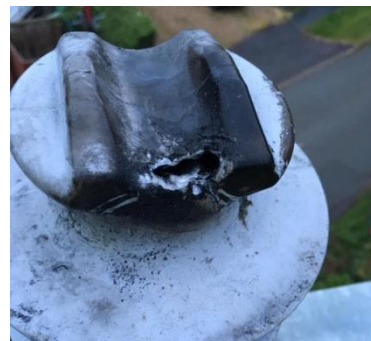
On 4th June 2019, in the Wirral District in SP Manweb, following a patrol of an HV overhead line fault, a reclose of the circuit resulted in a conductor dropping to the ground. Subsequently, a faulty 11kV polymeric pin insulator was found on the pole where the conductor failed (see fig.1).

Fig.1 – 1st failed pin insulator

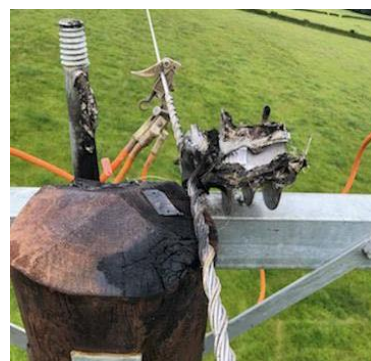
On Friday 14th June 2019 a second failed 11kV polymeric pin insulator was discovered during a post refurbishment audit by the OHL service partner. This line had been energised on Monday 10th June 2019. This line had not tripped, the insulator was sitting on the steelwork, and the pole top was burnt (see fig.2).

Fig.2 – 2nd failed pin insulator

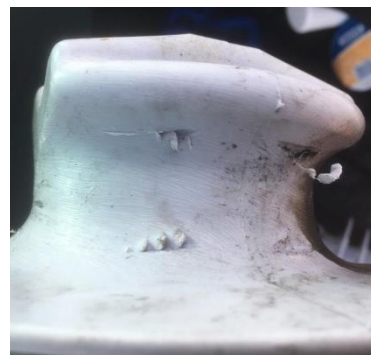
Initial investigations have identified what appear to be teeth marks from a Stilson wrench, or similar tool (see fig.3).

Whilst it has not been established if this is a factor in the failures, this serves as a reminder that pin insulators should be hand tightened only, as per trained procedures.

Fig.3 – Marks on failed insulator

- Communicate to all lines staff and contractors that the use of a Stilson, or other tools, to tighten an insulator is NOT a recommended procedure and should cease immediately.
- Ensure Service Partners are carrying out appropriate audits following work.
- As a general reminder, when energising any apparatus following work (or during fault switching), ensure that, where practicable, all staff, contractors and public are clear of the apparatus. ([OPSAF-12-004](#), Section 10.2.21).
- A detailed forensic investigation into the failure of these insulators has been initiated by Engineering Design & Standards. Further updates will be given following the investigation.
