WHEEL BECOMES DETACHED WHILE DRIVING ISUZU D-MAX MEWP

OVERVIEW

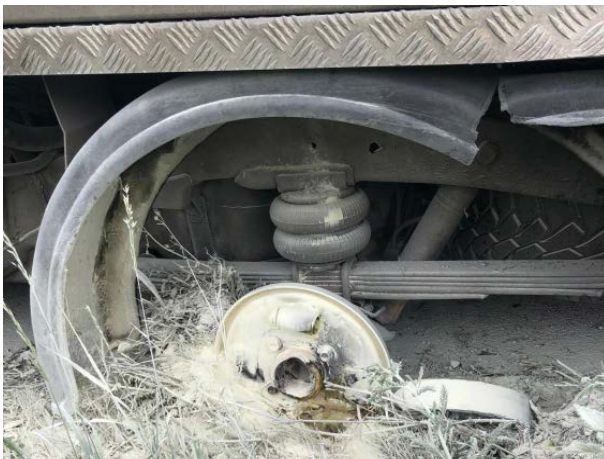
A wheel became detached from an Isuzu D-MAX MEWP while travelling on the A12. Indications are that the rear near side half shaft snapped causing the whole wheel and brake drum to become detached from the vehicle.

Isuzu technical services have inspected the wheel and reported that this was an isolated incident and would not have been detectable during maintenance. The likely cause for the half shaft snapping is a wheel bearing seizure.

- Conduct daily visual checks on the wheels to look for signs of overheating (wheel nut indicators melting, discolouration).
- Listen out for noises coming from the wheels while driving. If an unusual noise is heard, stop and call transport services for advice.
- Report any defects to Transport **0800 328 6484** who will arrange for further inspection and repair.
