Crush Injuries Result in Fractured Pelvis

On Thursday 30th November 2017, a member of the project team working in North Wales suffered serious injuries as a result of being crushed by a 132kV wood pole structure. The injuries were so severe that he was immediately air-lifted to hospital in Liverpool.

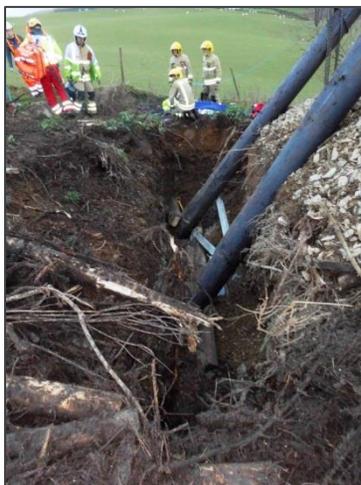
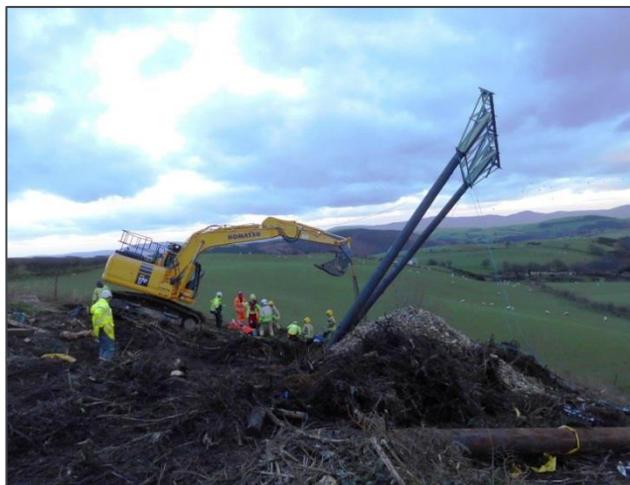
The activity being undertaken was the erection of a Heavy Duty Wood Pole (HDWP) structure, which comprised of two poles, the top level steelwork, and the braces and baulks at the bottom of the structure. In total, a structure weighing in excess of 3 tons that became unstable and resulted in crushing the team member within the excavation.

The full extent of the injuries included two blood clots and a fractured pelvis, which resulted in over six hours of surgery the following day. The post-operative care has commenced including skin grafts to his thighs, and physiotherapy for his pelvis and legs.

- **Ensure you are familiar with, and comply with, the Risk Assessment and Method Statement for the work you are involved in**
- **Ensure you understand the risks and hazards associated with the work activity**
- **Only undertake work if you are competent to do so**
- **Think before you act and be confident to speak up if in doubt**
