Safety Bulletin No. 13/2017

POLE MOUNT CUT-OUT FUSE – HENLEY PC400

Issue date	18 December 2017
Issued by	Vincent Cranny, Head of Health, Safety & Environment
Applicable to	Overhead Linesmen and Engineers

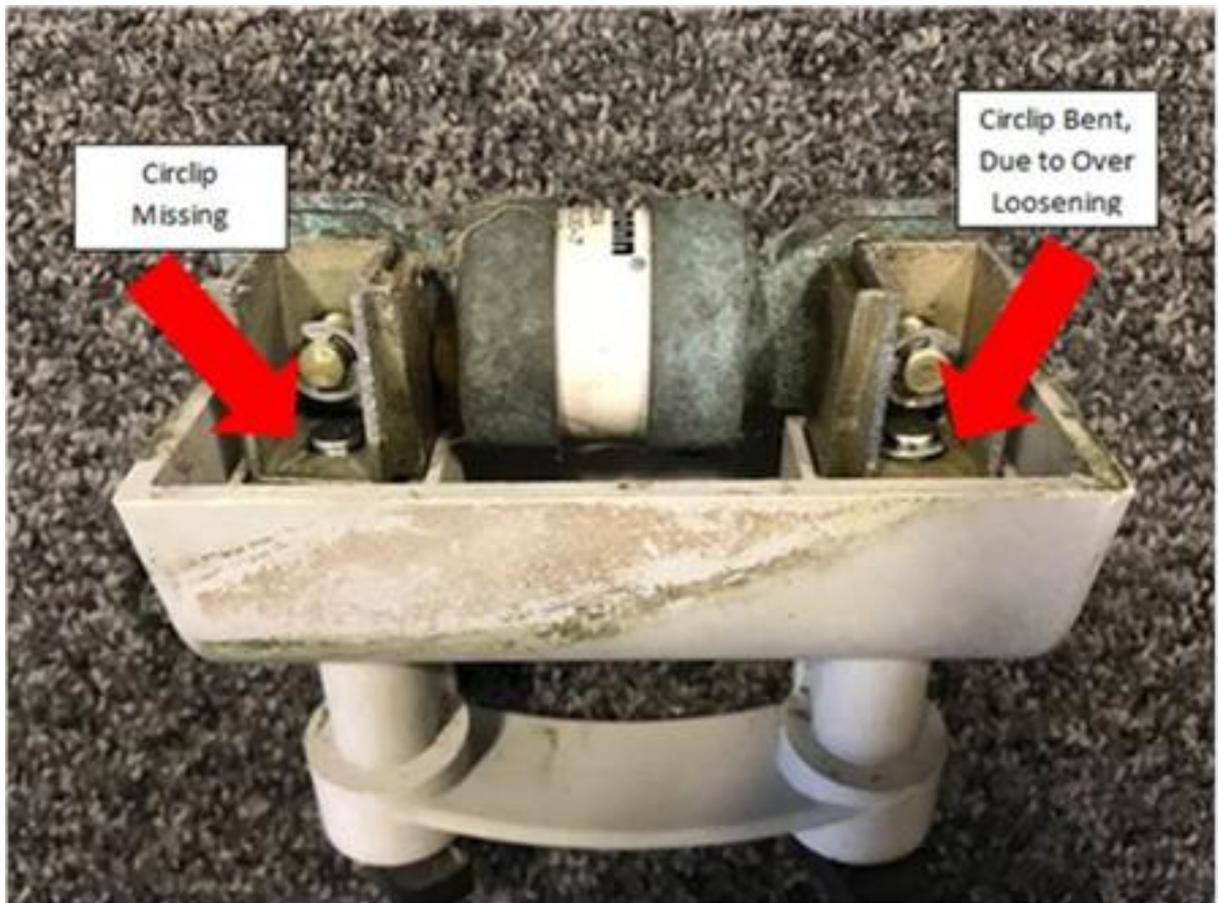
During the loosening of the fuse carrier wing nuts on a Henley PC400 Pole Mounted Fuse Cut-Out, a 'circlip' became dislodged causing the fuse to separate from the carrier resulting in the fuse being retained in the fuse mount.

When unwinding the wing nuts as soon as resistance is encountered no further pressure should be applied as this may cause the 'circlip' shown below to fracture or pop off and result in the fuse holder coming adrift of the fuse.
