## Hawkgas 12 Operational Considerations

Recently there has been a disruptive failure of a Hawkgas 12 (HG12) CB at ICI Waterloo Road Substation in Widnes.

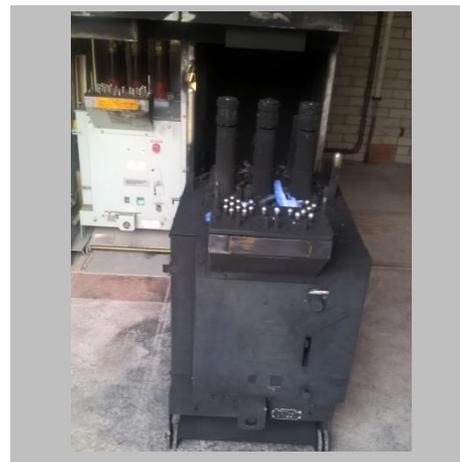
Initial investigation points toward environmental factors and partial discharge (PD) activity previously observed at the site as contributory factors.

*ICI Waterloo Road - HG12 Disruptive Failure*

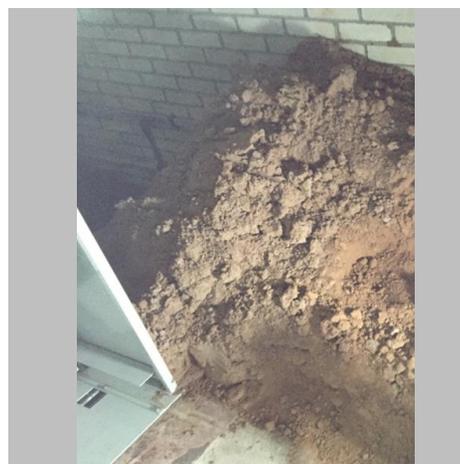
Special attention should be afforded to sites where environmental conditions are or have been previously known to be poor (e.g. damp or dusty environments).

*ICI Waterloo Road – Previous Site Conditions*

In sites with poor environmental conditions, further investigation is required to identify if conditions have had any detrimental affects on the switchgear.

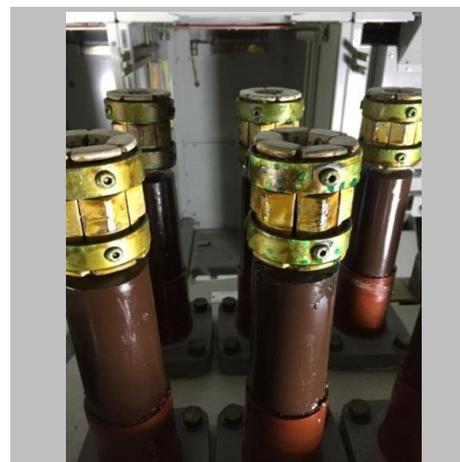
*ICI Waterloo Road – Corrosion on the bushings of CB previously replaced on site*

All HG12 CBs withdrawn from the service position, shall be visually inspected and shall not be returned to service if there is visible deterioration on the bushings or contacts.

Such instances of deterioration shall be reported to the Engineering Services department
