SAFETY BULLETIN SB 7/2017

MISSING STITCHING ON SIROCCO UH238 SAFETY HARNESS

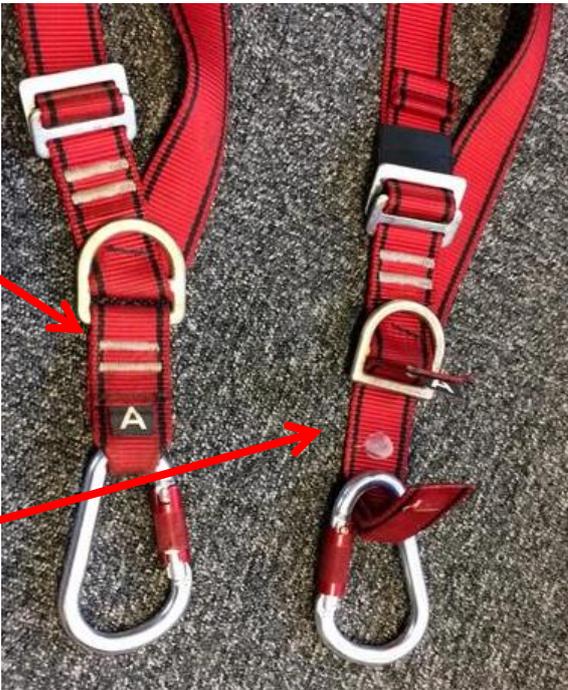
Correct stitching can be identified by two lines of stitching as shown here.

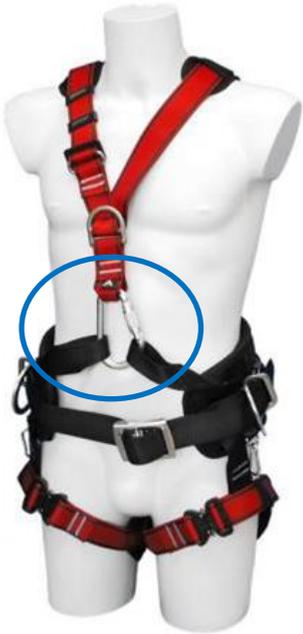
Essential stitching was found to have been missed during manufacture, resulting in the front karabiner not being effectively secured to the shoulder strap. The extent of this manufacturing defect is currently being investigated.

Failed unit. No stitching present. Webbing secured by glue on faulty unit.

All staff who have been issued with a SIROCCO UH238 SAFETY HARNESS shall, before the harness is used, check for any missing stitching as identified by this Safety Bulletin.

Any defective harnesses shall be IMMEDIATELY withdrawn from use and reported either by the Equipment Defect Report App or via the Equipment Defect Report Form (located on the Purchasing & Inventory Corporate Info Page).
