## Wood Poles treated with AC500

## Newsflash - 2018 03

06/02/2018

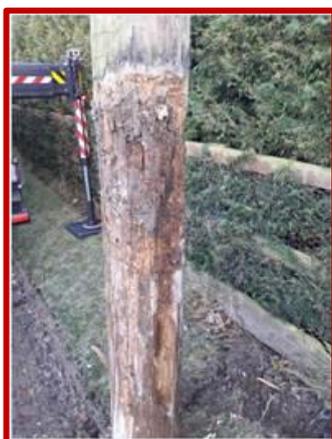
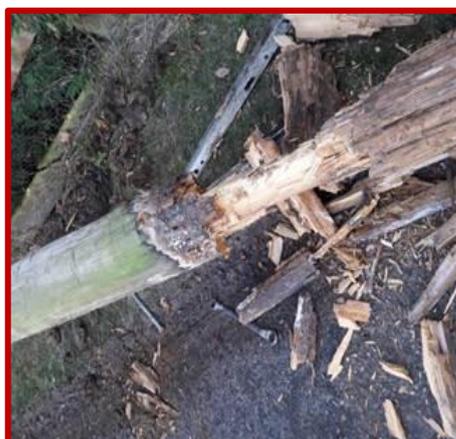
The safety newsflash is to make all linesmen aware of **additional precautions and controls that are needed when working on** wood poles treated with AC500 preservative. The photos below are from a recent incident involving a premature pole failure associated with an AC500 treated LV pole. Despite the pole appearing and sounding solid above ground, significant decay was found below ground level rendering the pole unstable and dangerous.

A customer reported an LV pole swaying in the wind which resulted in our staff attending site to deal with the report. Site staff confirmed stability issues with the pole which resulted in the pole being jacked out, and inspected. As can be seen from the photographs, the decay process has taken place below the ground line. An initial visual inspection of the pole appeared to show it to be in good condition. However the pole below ground level was severely decayed. The wood from the ground level mark was checked and all the outer softwood fell off the inner heartwood in chunks. Given that the majority of the pole strength resides in the outer ring of the pole, it can be seen that the residual strength of the pole was severely compromised.

The following risk control measures should be taken by all linesmen prior to working on poles treated with AC500 to assess the stability/integrity of the pole.

<b>1</b>	Check the integrity of the pole above ground using the hammer test, prodding test and visual tests as detailed in NSP/004/112. Poles treated with AC500 can be identified by the pole scarf marks or engraved label which will indicate a pole treatment code using the letters "AC". <u>The normal above ground inspection alone is insufficient to permit work on an AC500 treated pole – additional precautions are required.</u>
<b>2</b>	In line with working at height hierarchy, work should be carried out from a MEWP wherever practicable. Climbing of poles treated with AC500 is prohibited without further robust checks to confirm the poles integrity below ground.
<b>3</b>	In addition the only pole top works that can be carried out from a MEWP are where it is assessed that there will not be any significant changes in mechanical loadings on the pole and the conductor tensions will not be disturbed. If these requirements cannot be met then the pole must be subjected to the below ground inspection prior to the works being commenced.

<b>4</b>	If climbing is the only available method, poles treated with AC500 must be inspected below ground level by excavating a min of 300mm below ground and repeating the same checks below ground for signs of decay. <u>Only after confirming that the pole is in sound condition below ground level may the pole be climbed.</u>
