FAILURE OF A COPPER SALT TREATED POLE

An incident has occurred in Northern Powergrid with a 2007 copper salt treated wood pole.

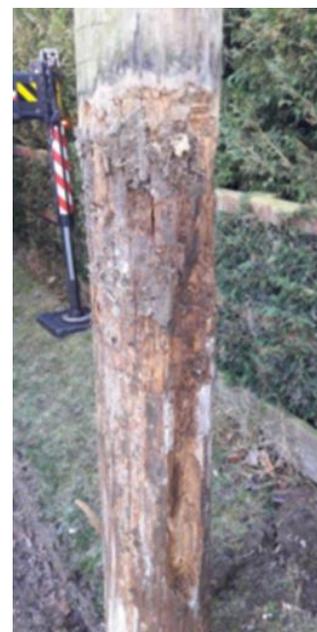
A customer reported an LV pole swaying in the wind which resulted in their staff attending site to deal with the report. Site staff confirmed stability issues with the pole which resulted in the pole being jacked out, and inspected. As can be seen from the photographs, the decay process has taken place below the ground line. An initial visual inspection of the pole appeared to show that it was in good condition, however, the pole below ground level was severely decayed. The wood from the ground level mark was checked and all the outer softwood fell off the inner heartwood in chunks. As the majority of the pole strength resides in the outer ring of the pole, the residual strength of the pole was severely compromised.

Pole jacked out of the ground

- **In line with the working at height hierarchy, work shall be carried out from a MEWP wherever reasonably practicable.**
- **Prior to climbing a copper salt treated pole (including the use of ladders), ensure that the barrier sleeve can be seen above ground level.**
- **As the decay below ground cannot always be detected by sounding the pole above ground, where the barrier sleeve cannot be seen above ground level and climbing is the only viable method of pole top access, the pole shall be inspected below ground level by excavating a minimum of 300mm below ground and repeating the same checks below ground for signs of decay. Only after confirming that the pole is in sound condition below ground level shall the pole be climbed.**

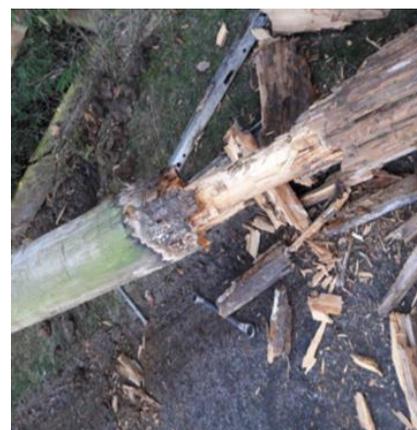
Severe decay below the ground line

In order to prevent this from happening, all copper salt treated poles coming to SPEN are fitted with a protective barrier sleeve by the pole supplier prior to delivery, though some of the initial poles were erected without the sleeve. The sleeve is located on the pole below ground level up to 150mm above ground level and this stops the copper tolerant organisms from having access to the wood, therefore preventing this decay.
