Checks of MEWPs

| Issue date | 16 February 2018 |
| Issued by | Vincent Cranny, Head of Health, Safety and Environment |

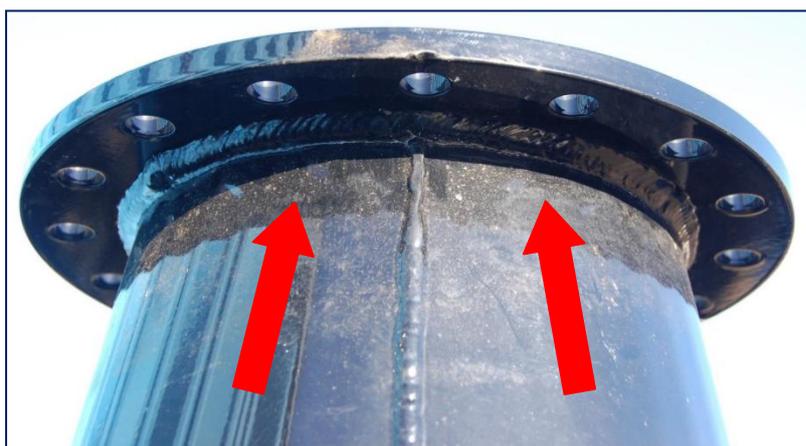
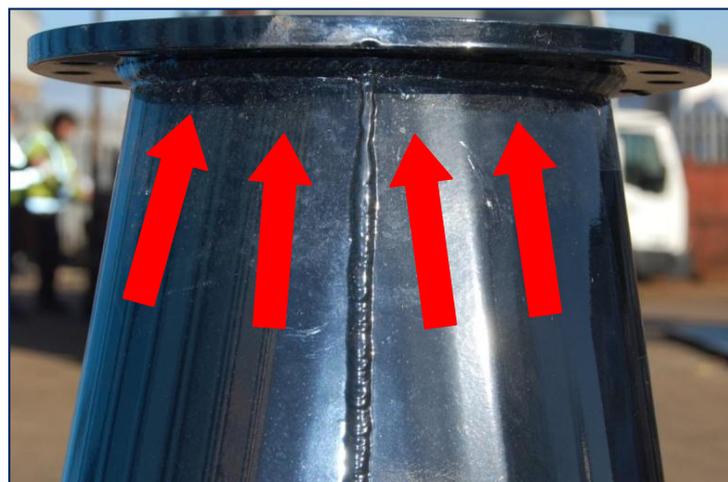
The cause of the incident has now been identified as an undetected fracture on the turret around the area below the flange weld. The crack was caused by multiple stress fractures around the turrets surface and the top part of the butt weld. The MEWP models associated with this include the Socage A314s mounted on Toyota Hilux's in use in ENW.

All ENW MEWP operators must check on the turrets for signs of fractures or defects around the circumference surface, the flange weld and both the front and rear longitudinal butt welds (as indicated on the photographs below). It is imperative that this is carried out as part of the daily and pre-use checks along with all other structural and moving parts. If any defects are found the MEWP should be taken out of use and the defects reported immediately.
