Newsflash - 2018 05**12 April 2018**

Wood pole collapse during attached climbing work

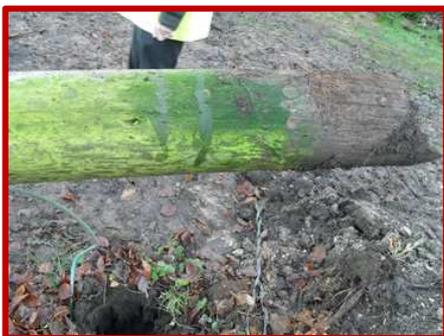
The pole where the service disconnection was being carried out was a 1950 (67 year old), light construction pole and was one of three poles on the overhead service. The linesman carried out a hammer test of the pole which did not identify any issues giving him concern. He decided to climb the pole using manual climbing techniques utilising his harness and pole choker. Whilst working at the pole top to disconnect the service span the linesmen felt the pole move and then start to fall to the ground with him attached. The linesman landed on soft ground suffering injuries which could have been far worse.

**Pole butt failure**

The investigation into the incident concluded that the hammer test was ineffective in detecting wood pole decay below ground level and therefore with immediate notice, additional enhanced safety measures are required in order to confirm the integrity of wood poles prior to climbing.

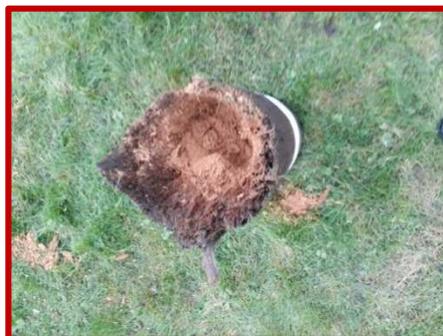
The photos below show the site following the incident with the section of the pole from below the ground and 300mm above ground. The below ground section clearly shows the extent of the rot and, despite the pole appearing sound and solid above ground, there was significant decay found below ground.

**Below ground section.**

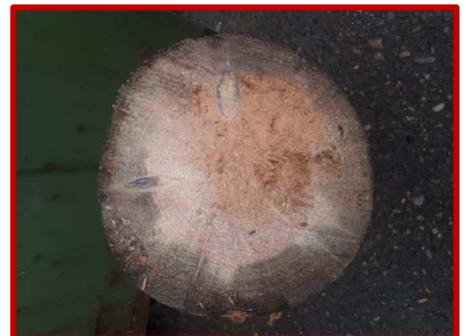
**300mm Above ground section**
