HV Cable Opened In Error

On 11th March 2018 an HV cable was opened in error at Strathore Road, Thornton, Fife. Fortunately, on this occasion there were no injuries to any of the personnel on site.

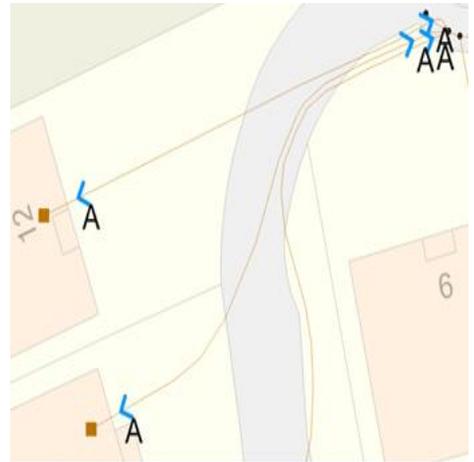
Geofield assumed route

Previously, Geofield displayed an assumed route with 'end-point' arrows and a capital **A**, as per the example above, on the right.

UK IT are working to revert the display back to the previous version used in Geofield (example top right).

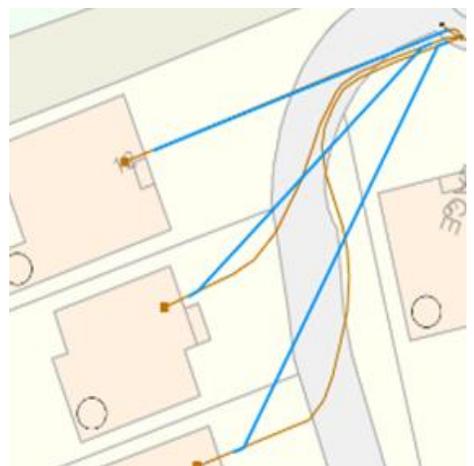
Geofield Pro assumed route

The cable records were misinterpreted and the jointer was working on the understanding that there was only one HV cable in the vicinity. A significant contributing factor to this, is a change in the way in which Geofield Pro renders an assumed cable route on screen.

Now, in Geofield Pro, an assumed route is displayed as a thick blue line, as per the example below, on the right.

NOTE: The Geofield Pro display of an assumed route is similar in appearance to that of a cable duct, only slightly thicker.

- All Team Leaders / Line Managers **SHALL** ensure that all of their staff are made aware of how Geofield Pro displays assumed routes, as detailed in the email from Field Support Group, dated 15th March 2018.
- Geofield Pro users **SHALL** take cognisance of the information contained in the above word document.
