SAFETY BULLETIN SB2/2018

LV Flashover when inserting a fuse in an LV link box

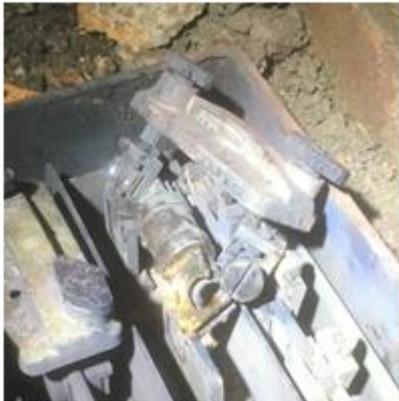
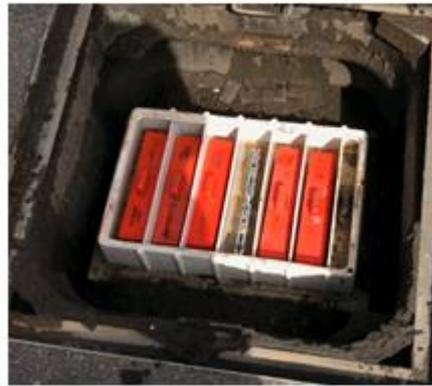
Whilst it was being inserted the fuse came out of the carrier because the screw that holds it in place was not fully tightened. The carrier inadvertently bridged the gap between the live stalk and the boss on the neutral link over the phase barrier and a flash over occurred. The operator was wearing correct PPE including a safety helmet fitted with a visor, but as he hadn't pulled the visor down he received burns to his face.

- Always check the condition of any fuse prior to fitting it to the carrier and ensure all retaining screws holding the fuse in place on the carrier are tight and have not come loose in transit before inserting it into an LDB.
- Staff are reminded that: *Approved Arc & Fire Retardant (AFR) coveralls, Approved electrical rubber gloves and **Approved full face protection shall be used at all times** while carrying out LV Switching or LV Linking operations.*
- Company policy requires that when operating in an LDB: *'if it is reasonably practicable to do so, insulated link covers or other temporary shrouding material shall be placed over all exposed metalwork'*
