Work taking place on unsecured poles

This safety express highlights two major events which were identified recently during site & operational safety audits.

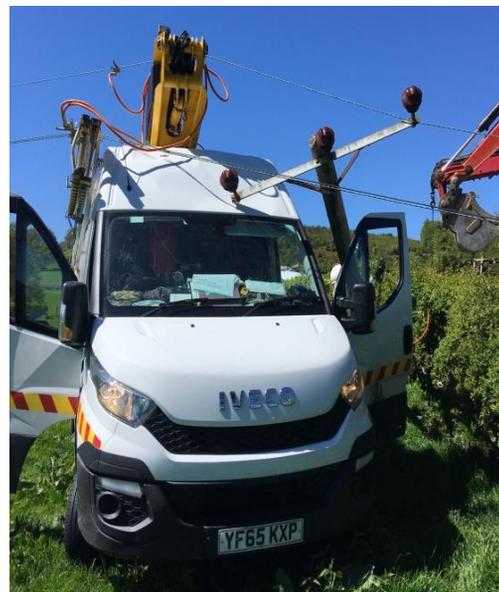
The first picture shows a pole that fell onto a service partner's vehicle during overhead line refurbishment. The pole narrowly missed the auditor and permit holder who were stood at the front of the vehicle.

The pole was to be replaced and a deep excavation had been made adjacent to the old pole. No support had been attached to the pole even though a HIAB was on site.

To review the requirements within the documents below, with all appropriate staff.

- [OHL-27-006](#) (*hyperlink to document*)
Release of Tension of Conductors and Safe Replacement of Poles
- [OHL-17-005](#) (*hyperlink to document*)
Pole Access
- [OHL-15-001](#) (*hyperlink to document*)
Excavations and Reinstatement Requirements for Pole and Stay Holes
- [OHL-16-002](#) (*hyperlink to document*)
Pole Erection

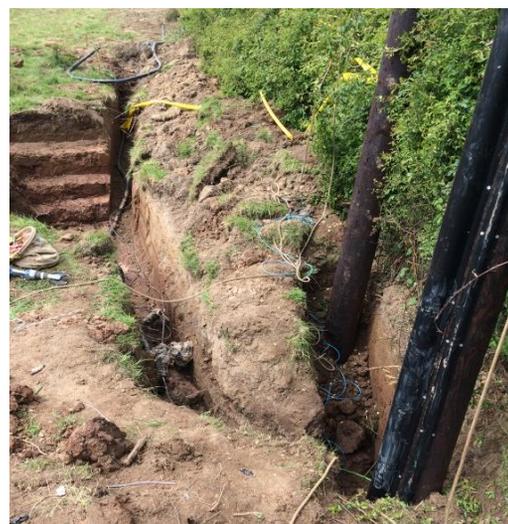
The second major non-conformance incident (*picture 2*) was a linesman undertaking work on an 'H pole' (substation pole) from climbing irons.

On inspection it was highlighted that the pole had not been sufficiently backfilled nor the ground compacted. The structure was further destabilised by the adjacent open cable trench and joint hole.
