## Disruptive Failures of 3M Trifurcating 33kV Joints

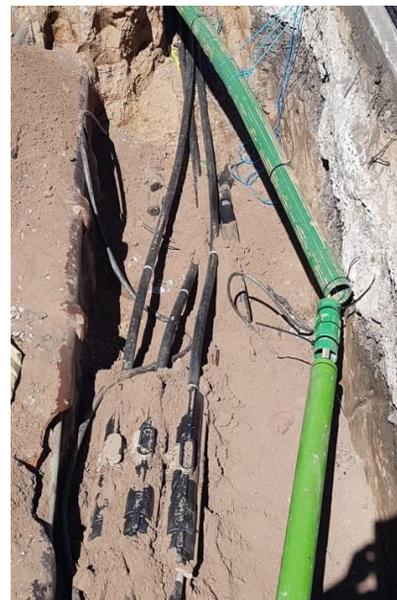
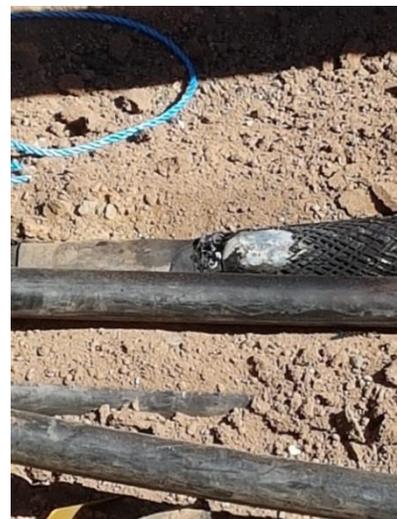
A spate of faults on the 33kV cable network have in the main been associated with the failure of a specific type of Trifurcating joint which was used during the period between 2002 and 2010. The joint is known as a 3M cold shrink 'Trif' joint.

Following repairs and sanding of the whole excavation, the faulted circuit was returned to service. Shortly afterwards the adjacent 33kV circuit was also re-energised to secure the system. Approximately 18 hours later the 3M 33kV trifurcating joint disruptively failed.

A similar event has since occurred on a separate 33kV fault location when a 3M Trif joint was discovered on an adjacent cable circuit. Upon discovery, works were ceased by the excavation team and the work area cleared. The site team contacted the Field Engineer to report the Trif joint discovery and shortly afterwards the Trif joint disruptively failed.

- Operational teams and excavation contractors involved with working on or adjacent to 33kV cables should make their teams aware of the details contained in this safety express and thoroughly examine UMV plans for joints of this type prior to excavating.
- Should plans indicate evidence of this type of Trif joint, then the risk assessment should be reviewed and appropriate action taken. This may include switching out the circuit or altering the network arrangements to mitigate risk. Similarly, if this type of joint is discovered during works, then work should be suspended, the area cleared until appropriate actions are agreed with the Field Engineer and Network Management Centre.
