## Working in Basements adjacent to BICC Trifurcating 33kV Joints

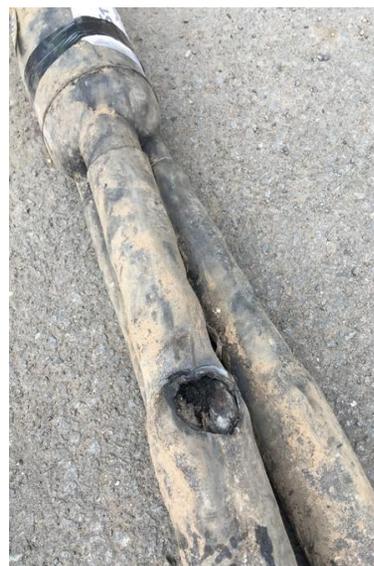
A high number of faults on the 33kV cable network have been associated with the failure of a BICC Trifurcating joint which contains a 3M component with a known failure mode. These joints were installed on the SPEN network between 2002 and 2010.

During recent repair works there have now been two separate incidents where other adjacent BICC joints have disruptively failed.
