# PANEL OF INQUIRY

## ScottishPower *Express*

Reference no.: EXP-14-086

## NON-COMPLIANCE RISKS LIVES

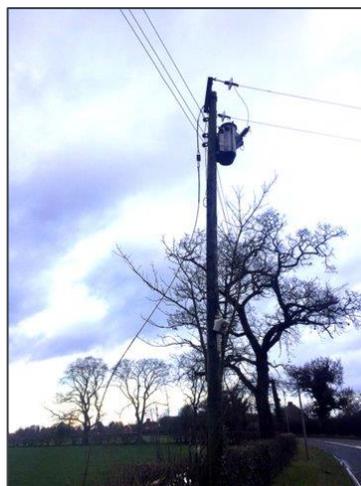
*Broken 11kV Terminal Stay*

On the 14<sup>th</sup> January 2016, a team of craftsmen attended site following a report of a broken terminal stay on an 11kV substation pole. Upon arrival, and following their initial assessment, the team categorised the defect as an 'I Hazard', although it was reported 4 days earlier.

- **Ensure the Reporting and Categorising of Defects (I, U & P's) are followed and applied**
- **The Planning and Setting to Work considerations are clearly known and understood by everyone**
- **All Site Specific Risks and Hazards are clearly documented and recorded (START)**
- **Ensure the required Signing and Guarding (traffic management) requirements are considered and applied**
- **Ensure the requirement to work live is justified and when undertaking work on wood poles supported by live conductors comply with the requirements of [OPSAF-11-006](#) (MSP 1.4).**

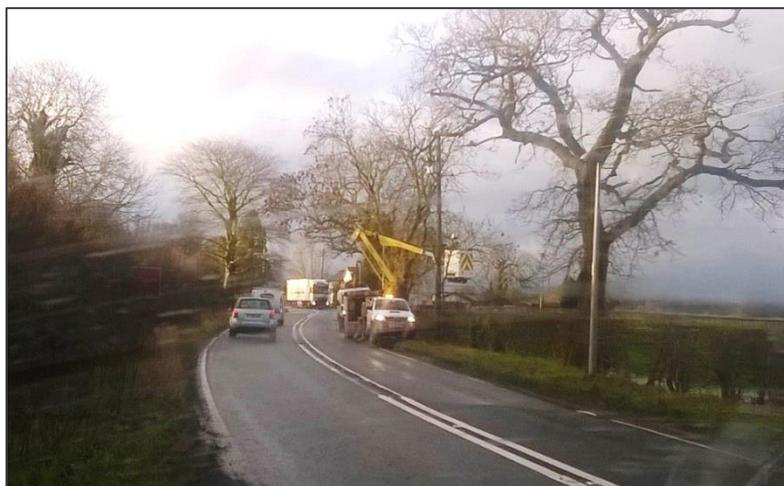
*Site Photograph (Source: Cheshire East Council)*

Following discussions on site and on completing their START risk assessment, the team proceeded to undertake the repair work. This involved positioning their vehicles straddling both the road and grass verge. The team also decided that the work could be completed with the 11kV overhead line, 11/0.23kV transformer and LV network all remaining live.

Both during and on completion of the work, SPEN were contacted by the Local Authority, who raised concerns about how the work had been undertaken on a main A class road, without notification and / or without any traffic management (non-compliance with NRSWA).
