Live HV Cable Opened in Error

On Thursday 8th December 2016, during the course of an LV UG modernisation project, a contract jointing team inadvertently stripped and removed the lead from a **Live** steel tape armoured HV cable and subsequently applied test equipment, resulting in a flashover.

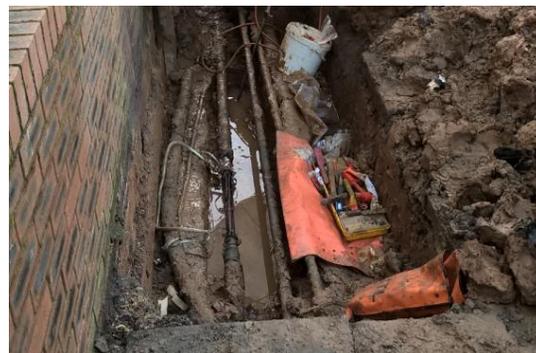
Picture 1: HV cable in trench

- When identifying LV cables, it is **essential** that you comply with the process defined in [PSSI 12 Appendix 1](#) - especially, where reasonably practicable, exposing all cables at the point of work

- Make allowance for errors or inaccuracies in operational records. Where there is doubt, use all available alternative sources to build confidence in the cable identification – e.g. detection instruments, archive records, requesting the isolation and identification of HV cables etc.

- Cease work and contact an SAP if a cable, thought to be LV, has only three cores or there is reason to suspect it may be HV e.g. it has a copper screen or metallised paper under the sheath

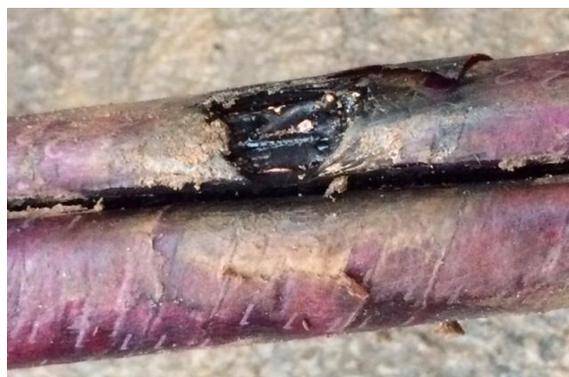
The jointer received burns to his hands and neck and was taken to a local burns unit for treatment.

Picture 2: the HV cable following application of test equipment

- If an HV cable is opened in error – this should be reported to the HV Control Person immediately.
- If an HV cable is opened, all unidentified HV cables present in the joint hole should be isolated where reasonably practicable until the identity of the opened cable is confirmed. If not reasonably practicable consider other precautions such as an additional excavation and tracing back towards opened cable.

- Ensure any known tape armoured HV cables are recorded on UMV.
- When new apparatus is installed it must be installed to specification and it is **essential** that data management records are updated with any fault or investment work that has been carried out.
