SAFETY BULLETIN SB 2/2017

Choke Strap – Webbing Damage

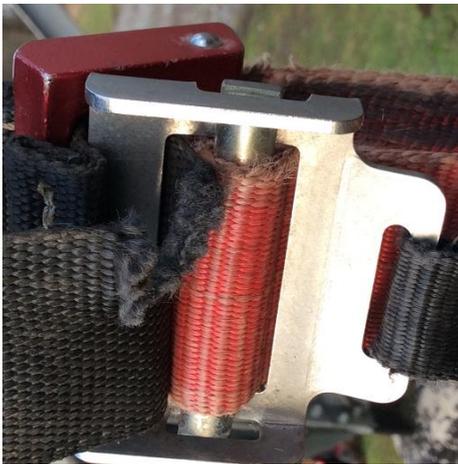
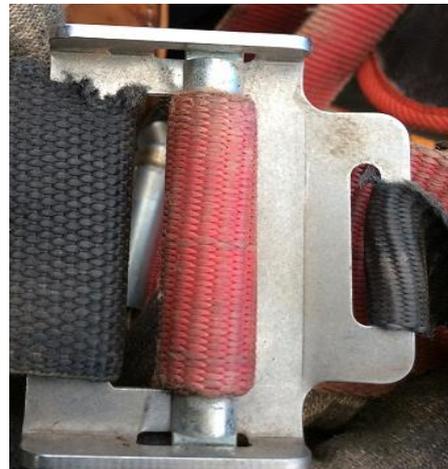
While a Choke Strap (pole choking lanyard) recently supplied by Safety Technology Ltd (STL) was being used to climb a wood pole its black webbing strap suffered a tear. The tear was heard by the climber who safely descended the pole where the strap was examined and found to be torn where it passes through the metal adjustable buckle.

Other Choke Straps that had been supplied at the same time were examined and a large proportion were found to also exhibit small cuts (1-2mm) at the edge of the webbing strap at the same position where it passes through the adjustable buckle.

All climbers who use the red and black STL Choke Strap shall therefore check their equipment with particular attention to the condition of the webbing strap in proximity to the buckles.

Any Choke Strap found to exhibit any damage such as shown above shall be withdrawn from service and quarantined locally until a replacement can be provided by the supplier.
