SAFETY CRITICAL **INFORMATION** **FLASH BULLETIN**

SCI Number: 17/07

Date of Issue: 22 June 2017

Subject: Cumberland/ SOGAGE MEWP - Catastrophic mechanical failure

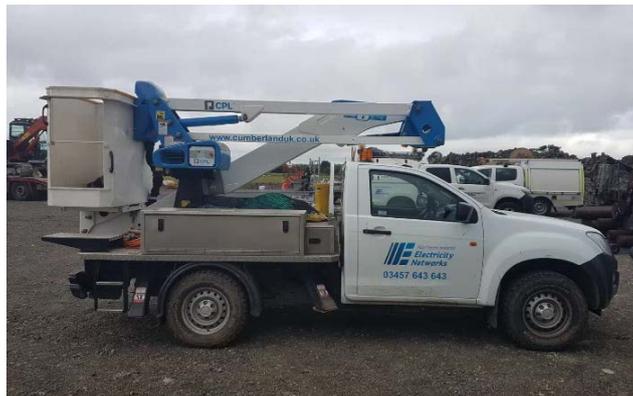
Photo 1

Yesterday afternoon during Tree Cutting work a Cumberland/ SOGAGE A314 MEWP (Photo 1) suffered a catastrophic mechanical failure. This caused the MEWP to detach from the vehicle and fall. The MEWP operator was injured as a result of the fall and taken to Hospital.

All Team Managers and Drivers of Cumberland/ SOCAGE A314 MEWPs have been instructed that **the MEWP must not be used.** This restriction must be enforced until further instructions are issued.

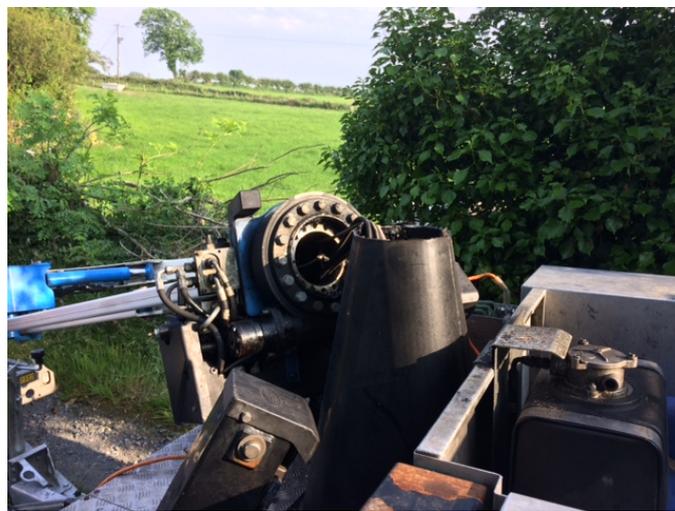
Photo 2

Investigations are in progress and we now know that a failure occurred at the turret of the MEWP (Photo 2)
