REPORT OF INCIDENT OR DEFECT OR ANY OTHER MATTER HAVING POSSIBLE SAFETY IMPLICATIONS REGARDING LIVE HIGH VOLTAGE OVERHEAD LINE WORKING

Date & Time of Incident:
9.20am on Wednesday 6th September 2017

Equipment involved:
Versalift IAD VOE36 MHI - buckets and levelling system

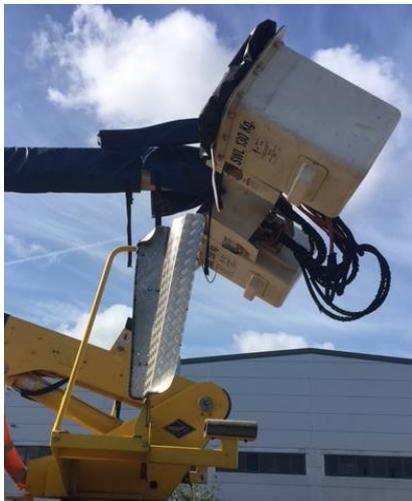
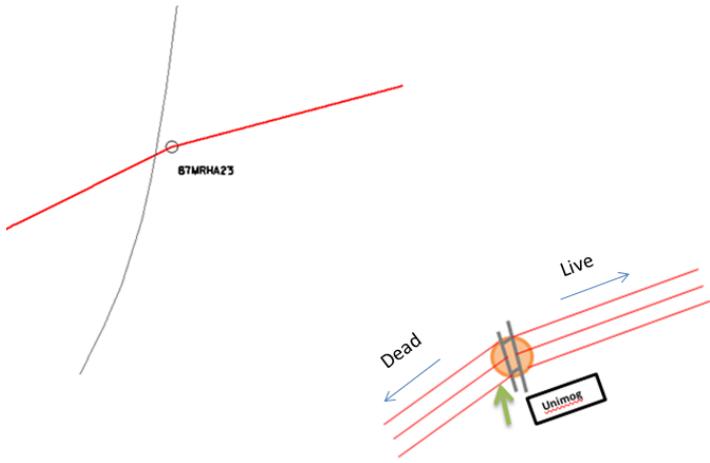
Whilst undertaking a Jumper Cut on the live 11kV line for tree cutting purposes, the IAD bucket self-levelling function failed; the green arrow in the diagram below shows the position of bucket.

They were working on the near side conductor. Shortly after this, without warning the team heard a large cracking sound and the bucket rotated backward at speed to an angle of 75°. The team were still at the work position and fortunately were able to remain in the bucket.

A thorough investigation at Versalift with an independent engineer present identified the cause for failure being a spiral roll pin that locates a pivot pin within the levelling system that had sheared which allowed the pivot pin to come out and the uncontrolled movement of the buckets.

- As a precautionary measure, an immediate recall has been initiated by WPD Transport to inspect all VOE36 MHI IAD platforms.
- Platform operators are reminded of the relevance of their own pre-use checks; if there is any doubt, do not use and return the vehicle to WPD Transport for investigation.
