PANEL OF INQUIRY

ScottishPower *Express*

Reference no.: EXP-14-088

11kV Flashover During Live HV Phase Check – Newton Stewart Primary

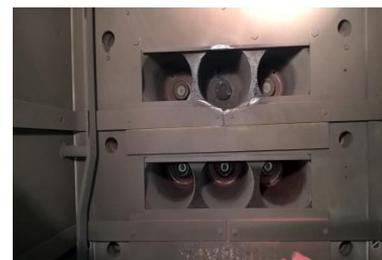
The source of the flashover was within the yellow-phase circuit (transformer) spout, on the fixed portion of the T2 circuit breaker. As the HV phasing stick was inserted into the spout, arcing occurred between the live contact and the switchgear frame resulting in a flashover. It is suspected that carbon residue within the spout provided a partially conductive path across the surface of the spout.

Fixed portion following flashover

- Always ensure a full understanding and strict adherence to live working procedures, including use of required PPE.
- SOP- 407 (restricting use of HV testers on Hawkgas12 switchgear) remains in place subject to completion of inspections of Hawkgas 12 CB spouts.
- OPSAF-12-004 LWM 2.2 (Operation of HV System) and OPSAF-12-005 LWM 2.3 (Use of Approved Voltage Indicators) are being reviewed to clarify the hierarchy of approaches for phase checking and will be communicated separately.
- Alternative approaches for carrying out HV phase checks are being investigated
- New signage is being rolled out via District maintenance engineers to improve company readiness to respond to emergency situations at remote sites.
- First aid procedures in relation to burn injuries are being reviewed.

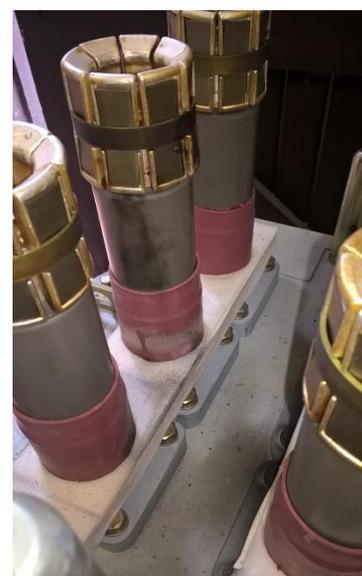
Investigations have identified no defect with the HV tester; no underlying issues with the Hawkgas 12 switchgear; and that all protection operated as designed. The most likely cause of the carbon residue within the spout was a low-energy flashover within the spout, at some point prior to the incident, while the circuit breaker was open but racked into the service position.

Evidence of carbon arcing on moving portion – conclusion that similar residue present on surface of CB spout
