UBB On-Load Tap Changer (OLTC)

The Wimpeys Pant Quarry 7.5/10MVA transformer failed in service on the 28th April 2016 at 17:41. Just a few hours earlier; at around 13:17, it had been returned to service following maintenance of the on-load tap changer (OLTC).

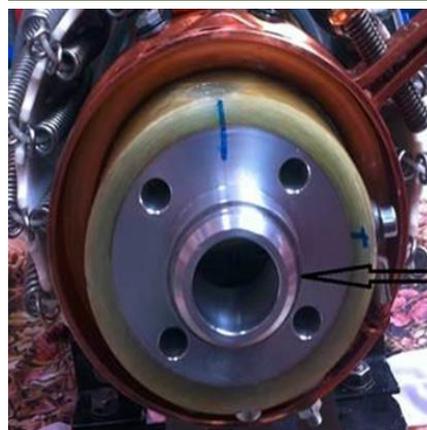
Bottom plate in correct direction

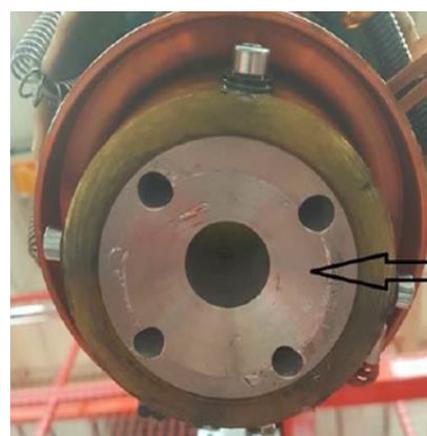
The conclusion of the failure investigation is that the bottom plate had been assembled in the reverse direction after maintenance. This resulted in mismatching contacts causing a short circuit and failure of the transformer beyond economic repair.

Bottom plate in incorrect direction

- Maintenance plans for UBB tap changers should be built from the commissioning date, and not automatically aligned with the wider maintenance activities.
- The bottom plate of the UBB type OLTC must be marked during its disassembly to ensure it is reassembled correctly following the maintenance.
- The failed transformer will be utilised for training purposes by ABB, who will also attend site during the maintenance of the next UBB tap-changer, to provide support.
- Discrepancy between training and maintenance manual to be raised with ABB as well as potential design improvements.
- Staff are reminded that if they are in any doubt on any aspect of maintenance of equipment, assistance should be sought either from an internal expert or from the manufacturer.
