# P1 Incident Involving MV Boosters

Issue Date - 22/01/2016

<b>SHIELD NUMBER</b>	<a href="#">15993</a>	<b>Date of Incident</b>	16/1/2016
<b>Incident Type</b>	Operational Incident Equipment Failure - OH Lines	<b>Incident Rating</b>	<b>S3/P1</b>

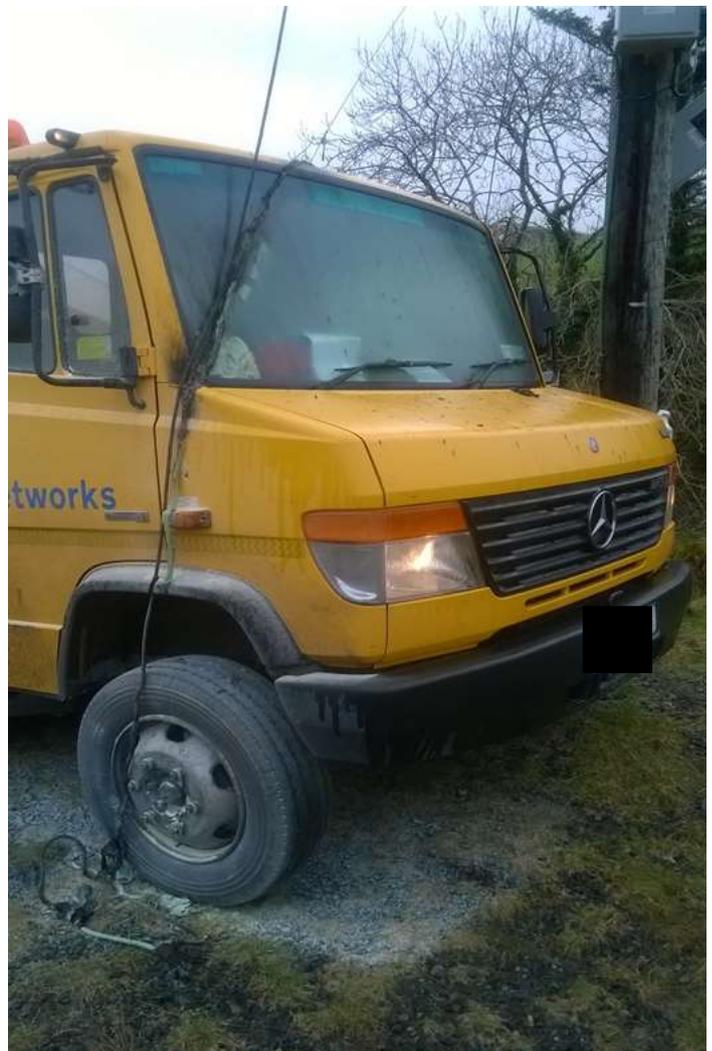
- A crew were involved in replacing a set of MV boosters.
- The new boosters were switched in for approximately 15 minutes and an NT was in the process of completing the commissioning tests.
- As the booster started to tap change a fault developed causing a release of oil from the main tank and a fire broke out on top which caused R phase conductor to burn down on top of an ESB truck.(see photo)
- Nobody was injured as a result of this Incident
- A full investigation is underway

- Ensure a copy of this Safety Critical Alert is provided to all staff
- Ensure OBN 215 - Precautions to be taken when operating Voltage Regulator By-Pass Disconnects (DOC-200116-CDB) is briefed to all operators and NTC Trainers

- Comply with requirements of OBN 215 - Precautions to be taken when operating Voltage Regulator By-Pass Disconnects (DOC-200116-CDB)
