Safety Bulletin No. 03(a)/2016

CRESTO 829C & 859C FULL BODY HARNESS

Issue date	14 March 2016
Issued by	Vincent Cranny, Head of Health, Safety & Environment
Applicable to	Employee issued with the Cresto 829C & 859C Full Body Harness

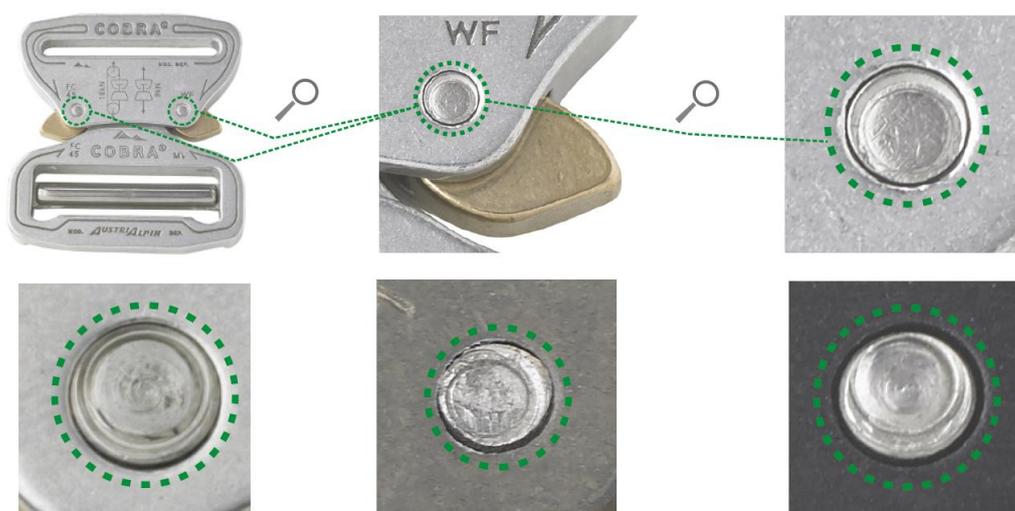
Correct

The rivet shows an embossing in the form of a ring on both the front and back sides of the rivet. Do not manipulate the rivets by mechanical action.

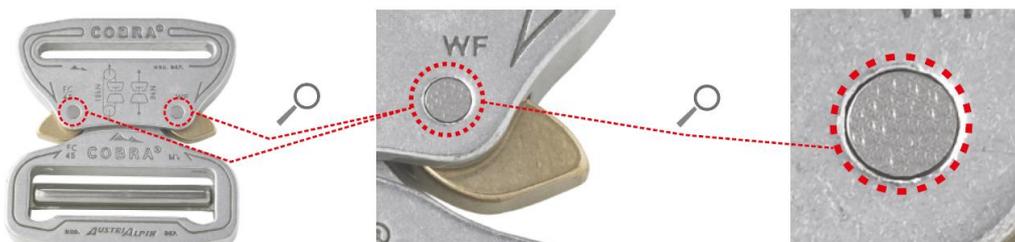
NOT Correct

The rivet does not show any circular embossing.

If you notice the buckle is NOT riveted correctly stop using the harness immediately.
