Update on Asbestos in Operational Premises

1. LV Distribution Boards clad with asbestos containing materials (ACMs)

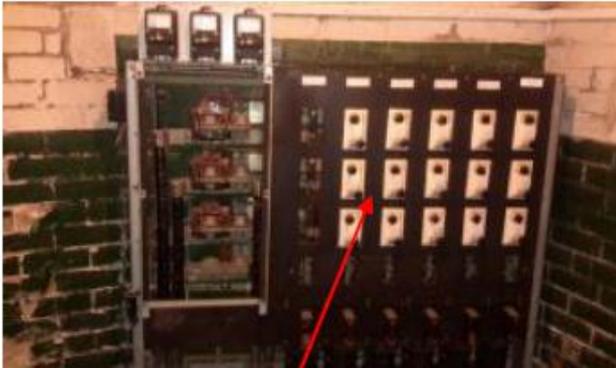
N-210665 WESTVILLE ROAD 4021

LV shrouding and cartridge fuses are presumed to contain asbestos.

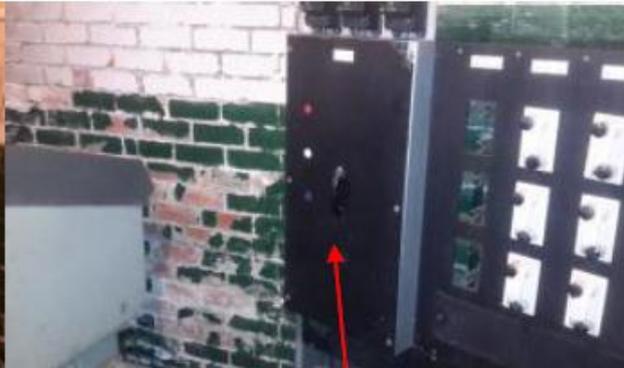
Transformer cover panel contains asbestos.

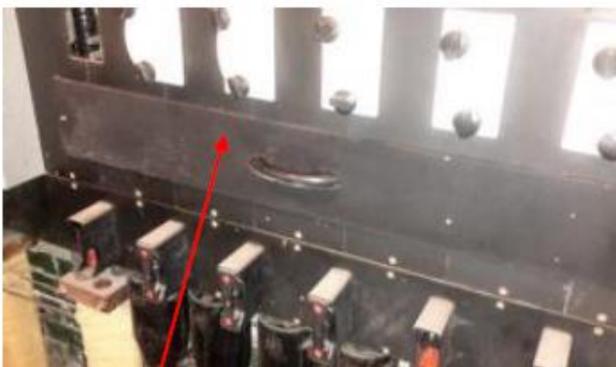
Blanking panel presumed to contain asbestos as per the transformer cover panel.

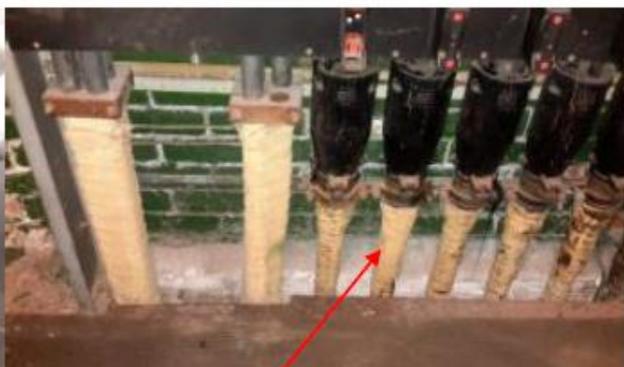
Cable wrap known to contain asbestos. Sampled as part of Redhills Management survey N-65393.

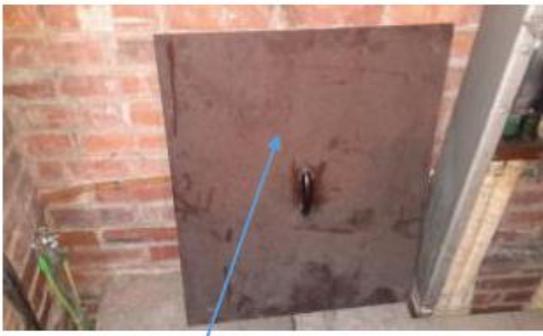
N-210665 ARUM STREET 568

No asbestos identified in LV cover panels.

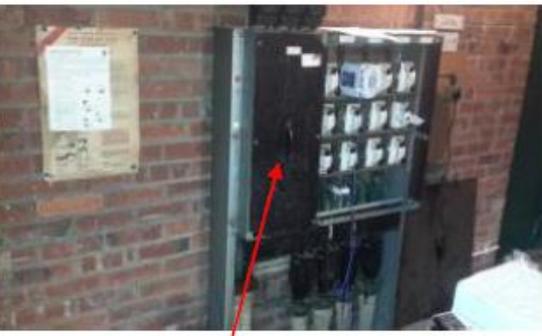
However asbestos previously identified in transformer cover panels as per Redhills Management Survey N-76604.

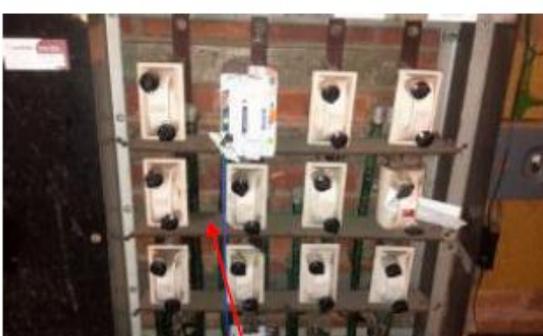
Phase barriers presumed to have an asbestos content as per the transformer cover panel.

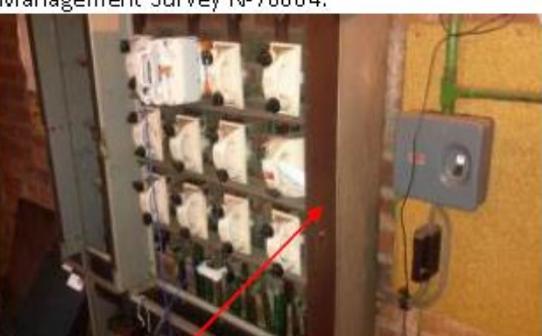
End shield presumed to have an asbestos content as per the transformer cover panel.

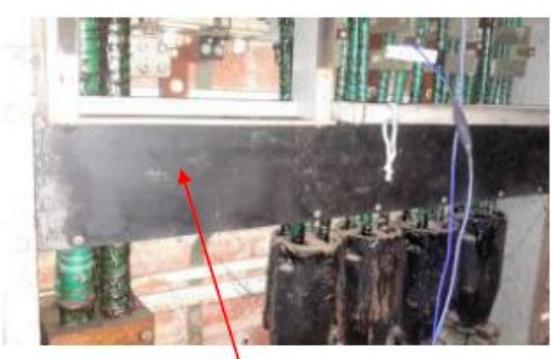
Cable shield presumed to have an asbestos content as per the transformer cover panel.
