## **Loose Wheel Nuts and Wheel Detachment**

Northern Powergrid Toyota Hilux vehicles have experienced two separate incidents of wheel nuts shearing on the rear near side (passenger) wheel.

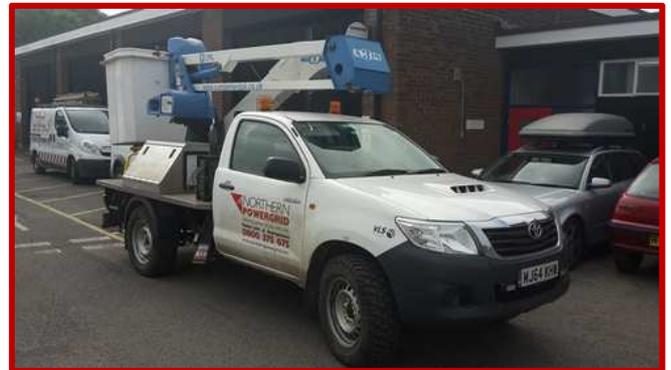
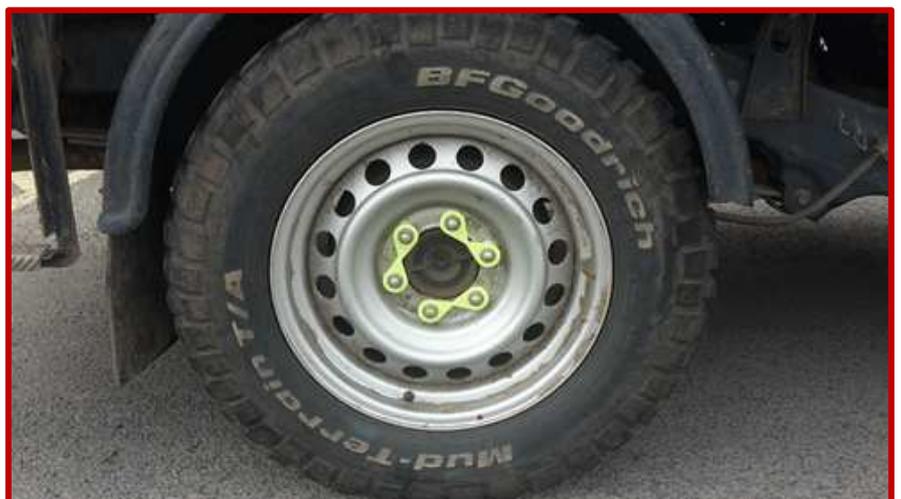
The investigations are taking into account a number of factors including service and maintenance histories, maintenance working practices, daily vehicle safety checks and defect reporting. In both cases, two adjacent wheel nuts had become loose with the remaining four wheel studs having sheared off. The reasons for the wheel nuts becoming loose are still subject to investigation. There is nothing to indicate that the manner of driving in either of these cases was contributory.

- As an additional preventative maintenance measure going forward VLS have also changed their own working practices by implementing a double-torque process which is seen as best practice in the medium and heavy commercial sectors. This process involves tightening wheel nuts to the manufacturers specified torque settings and then leaving the vehicle for a period of time before re-checking the torque settings after any settlement may have occurred.

- **VLS have also started to fit wheel nut indicator flags to light commercial vehicles where it is practical to do so.**
- **Wheel nut indicator flags are designed to help drivers to identify missing or loose wheel nuts during daily vehicle safety checks.**
