Fatal accident in Iberdrola Networks, Spain

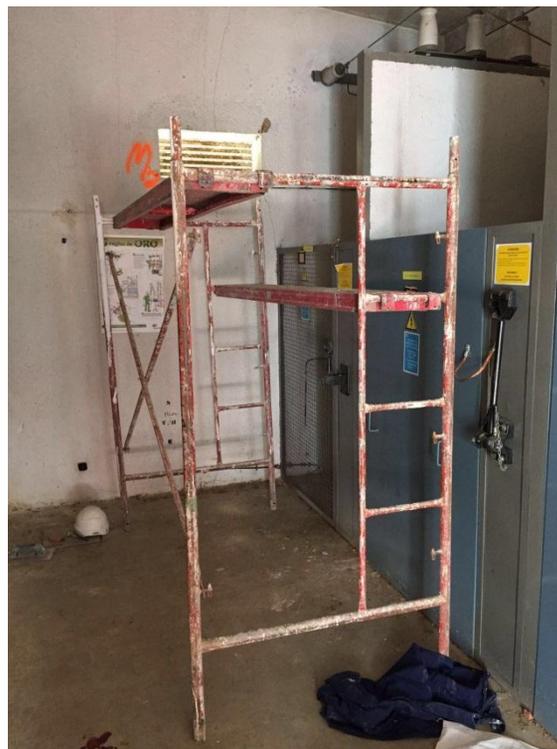
Work was planned for the main contractor to change connections on the 20 kV conductors and then for repairs to the external roof and internal walls and ceiling of the substation. Isolation of the high voltage apparatus was required before work could commence.

It appears that the civil contractor began assembling scaffolding in advance of the shutdown whilst the apparatus was still live. During the course of this he received an electric shock and fell, sustaining a head injury.
