PANEL OF INQUIRY

Reference no.: EXP-14-084

Incident: SP-POI- INC-1016349

LV Flashover at MFI Bidston S/S

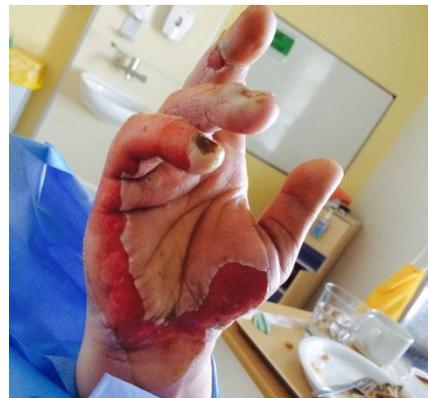
The jointer received severe burns to his right hand

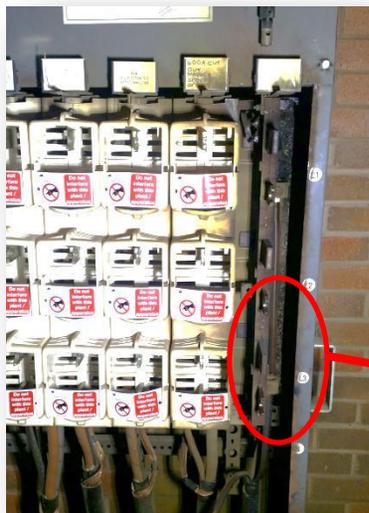
Upon shear-off, the jointer lost control of the tool, which made contact between one of the phase busbars and the earthed metal work of the enclosure. The 24MVA flashover caused severe burns to the jointer, who remained in hospital for three nights and is now undergoing physiotherapy.

At the time of this incident, the jointer was not using insulated tools, approved rubber gloves or light eye protection, and the insulating rubber mats were not in place.

Uninsulated ratchet spanner made contact between the live L3 busbar and the enclosure

- Always ensure full understanding and strict adherence to the live working procedures
- Always wear appropriate PPE & use appropriate approved insulated tools in accordance with PSSI 12 (13.3)
- If in doubt, stop work and contact your Team Leader immediately
- When undertaking any work on 'shielded-pattern' LV boards, always inspect thoroughly for the presence of exposed live conductors at each stage of the procedure
- When working under procedure WL-1.17 and exposed live conductors are identified, either make 'not live' or apply approved shrouding

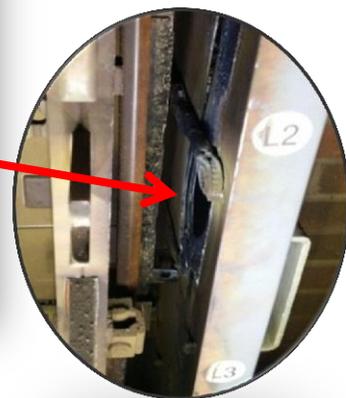
Under normal operating conditions, 'shielded-pattern' LV boards ensure that live conductors are shrouded. However, when fuseway covers are removed, live conductors can be exposed.

Be aware that the term 'shielded-pattern' only applies under **normal operating conditions**. Once fuseway covers are removed, there is a distinct possibility of exposing live conductors.
