**Accident while working aloft
on Wood Pole**

Issue Date - 28/04/2016

SHIELD NUMBER	17891	Date of Incident	16-04-16
Incident Type	LTI - Fall from a height	Incident Rating	S2/P2

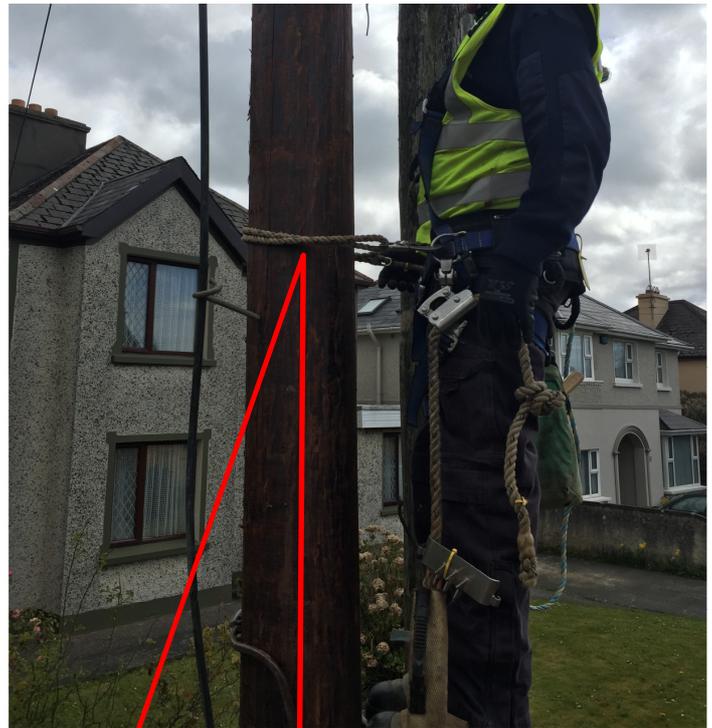
- An NT crew were replacing bare conductor with OBC and tying in new LV poles.
- Having climbed the new pole an NT was on his way down passing a D bracket with an aerial attached to it when he fell sideways and backwards.
- As a result the NT was suspended from his climbers.
- This resulted in a serious injury to both ankles.
- The incident is currently under investigation.
- This alert is a reminder to staff of the risks and control measures required while working aloft.

Auxiliary Belt shall always be engaged before the climb safe is disengaged at an obstruction.

- Ensure when climbing past an obstacle on a pole that the auxiliary rope Shall always be deployed and visibly confirmed that the Auxiliary Hook is engaged in the D Ring before the Climbsafe and Pole Rope is disengaged.
- When the obstacle is safely passed, re-engage the Pole Rope and Climbsafe visibly confirming the Pole Rope hook is engaged in the D Ring.
- Never disengage Climbsafe and auxiliary rope at the same time when working aloft.
